TEST: POSSIBLE STAINING ON NICKEL PLATED SURFACES

EKWB Internal Report

1.Reason and testing methods

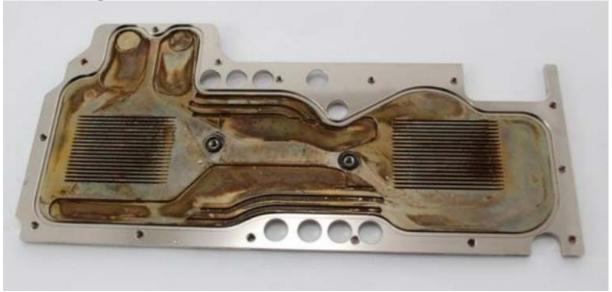
Before cleaning:

The stains/deposit on the nickel plated surface were clearly thick and ugly.

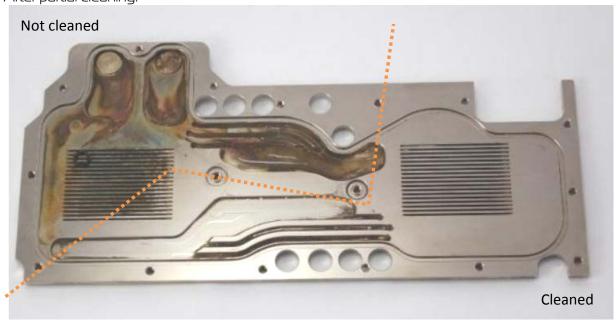
3.1.2. Dirt was difficult to remove from recessed areas. Polishing paste was used.

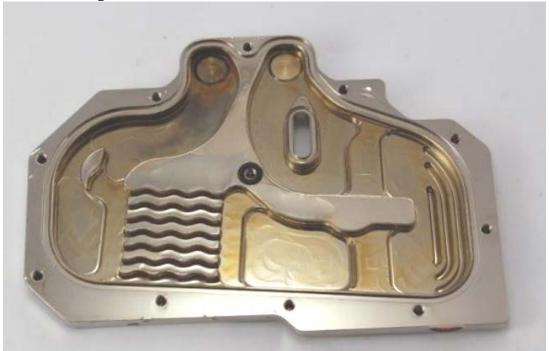
Before cleaning:

The discoloration/deposit on the nickel plated surface was not previously found in only distilled water systems. The discoloration/staining is very likely because of the high discoloration/staining of the EN block in the same loop, although much less intense. A standalone system has already been set up to exclude any influences from EN blocks on the nickel plated block.

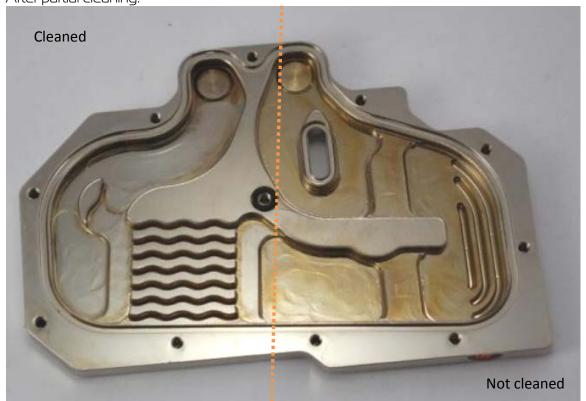
Cleaning was easy compared to EN block version.

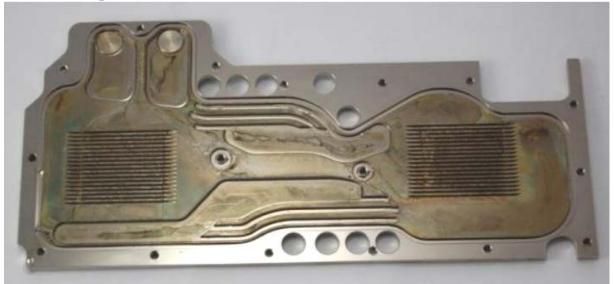
Before cleaning:

Before cleaning, the surface had similar but less intense discoloration/deposit compared to that observed in the distilled water only loop.

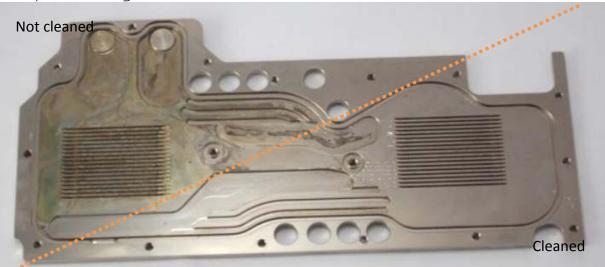
After partial cleaning:

The degree of staining itself was lower when compared to that observed in the distilled water only loop. Cleaning was uncomplicated using the polishing paste, however using a paper towel alone was not sufficient to clean the surface.

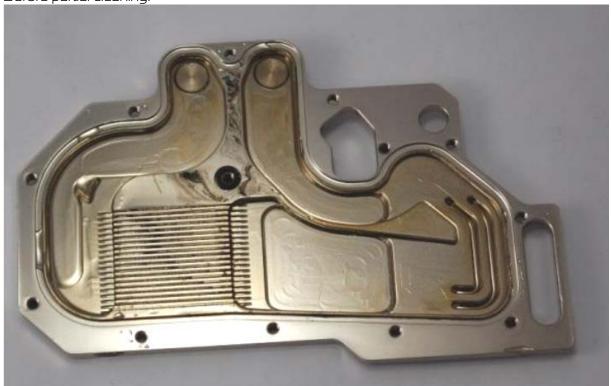
Before partial cleaning:

The block was cleaned using the polishing paste, as a paper towel alone was not sufficient to clean the surface. The result was as expected. There were already signs of possible corrosion at the those places where water flow is minimal – between the top and nickel plated base. The discoloration/staining is very likely because of the high discoloration /staining of the EN block in the same loop.

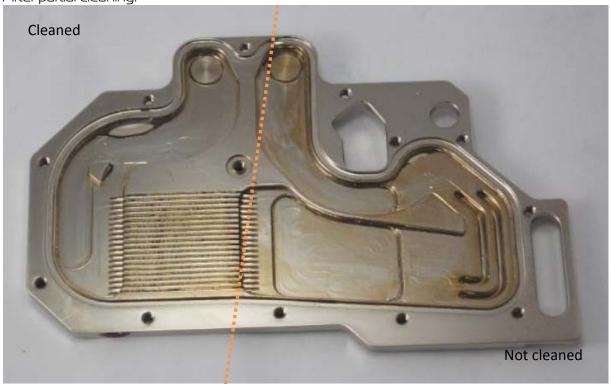
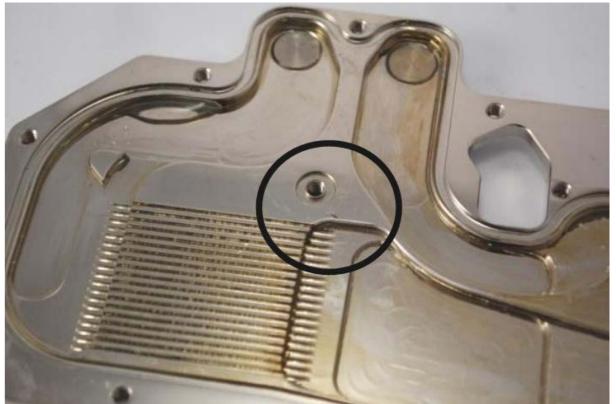
After cleaning the corrosion of the nickel plating was confirmed. The cleaning of the other surface was relatively easy.

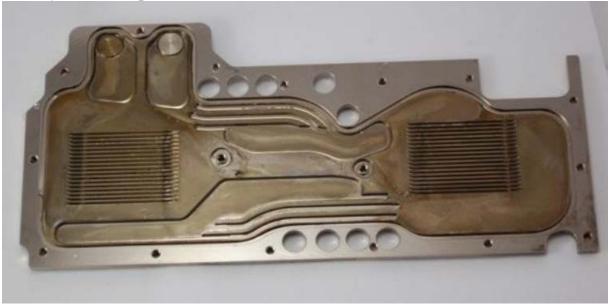
Before partial cleaning:

Before cleaning, the surface had similar discoloration/deposit when compared to the loop using distilled water only and the loop with Copper Sulphate based biocide.

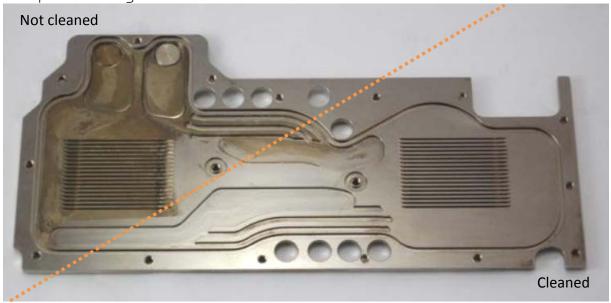
After partial cleaning:

Cleaning was made by polishing paste and was pretty easy. Using a paper towel alone was not sufficient to clean the surface.

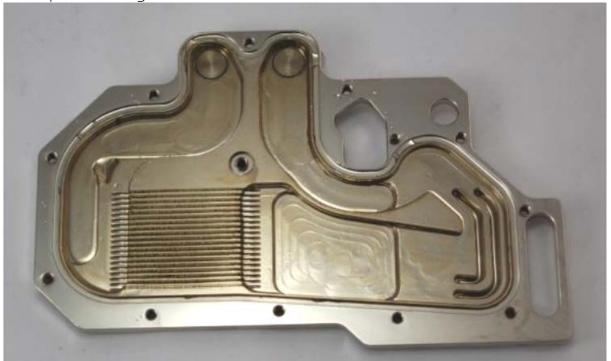
Before partial cleaning:

The discoloration/staining is very likely because of the high discoloration/staining of the EN block in the same loop.

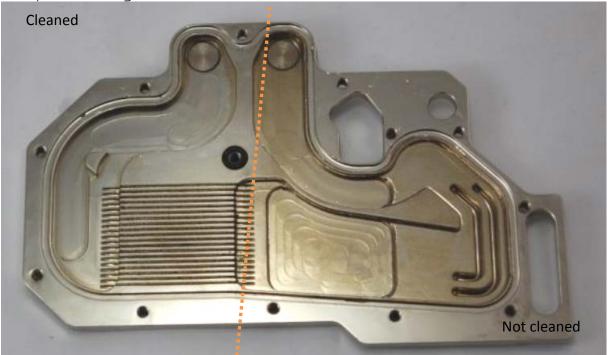
Cleaning with polishing paste needed little effort. Using a paper towel alone was not sufficient to clean the surface.

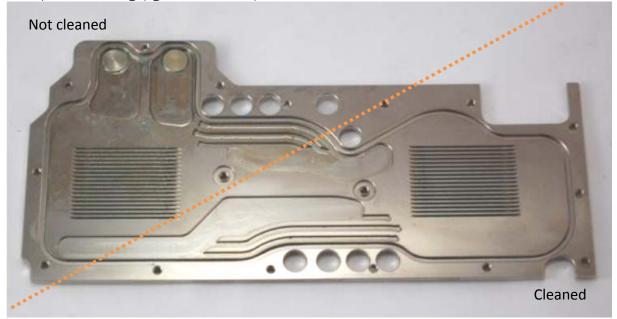
After partial cleaning (right, middle side)

The area where we used Ekoolant was easily cleaned by wiping with a paper towel. Discoloration was minimal and is likely to have been caused by glycol.

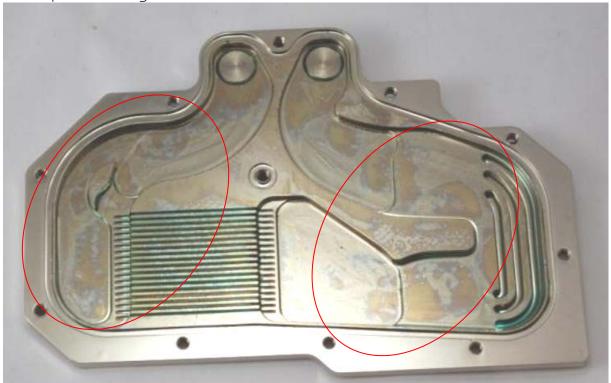
Before partial cleaning:

After opening the block, only a layer of drying coolant was left on the surface. The blue of the coolant is showing in the recessed areas where more of the blue coolant remained.

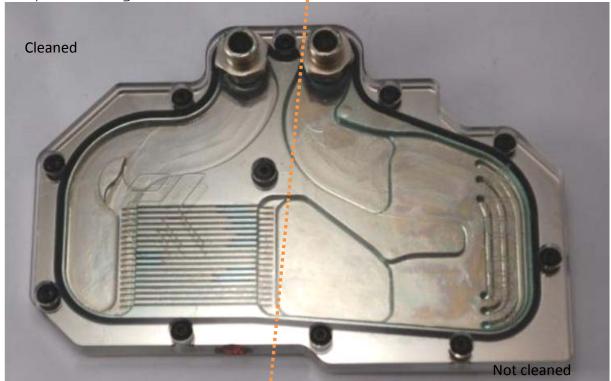
The area where we used Ekoolant was easily wiped by a paper towel. Discoloration is insignificant.

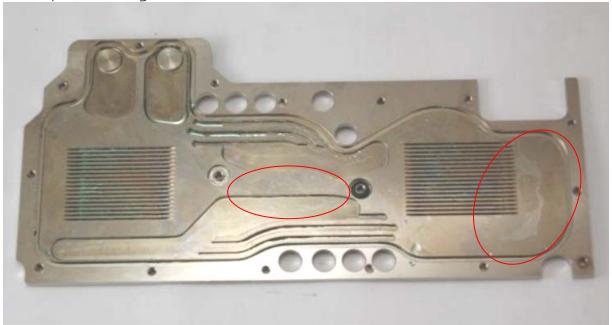
Before partial cleaning:

On the surface, only minor stains/discoloration can be seen caused by the drying layer of coolant. The slight blue cast that can be seen is due to the Blue Coolant. After partial cleaning:

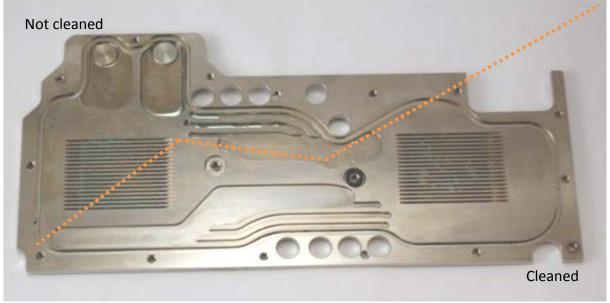
The internal channels of the block where Ekoolant was flowing were easily wiped by a paper towel. Discoloration is minimal.

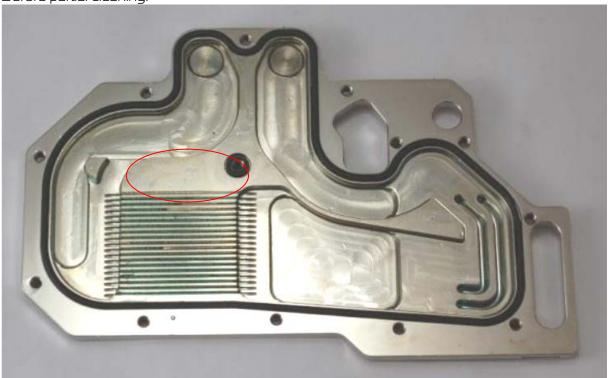
Before partial cleaning:

On the Galvanic nickel plated block used in the loop with Ekoolant, only minor staining/discoloration was detected.

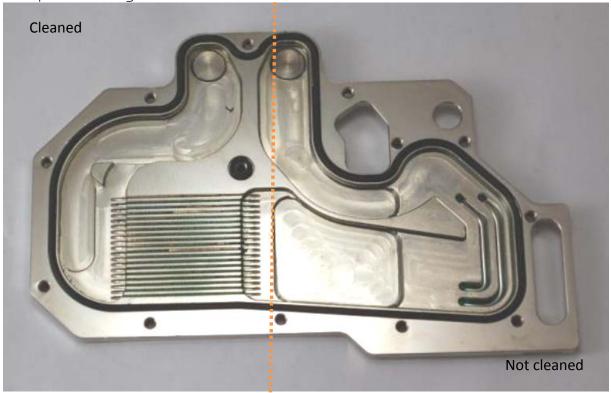
The areas where Ekoolant remained were easily wiped by a paper towel. No staining or discoloration remained after wiping.

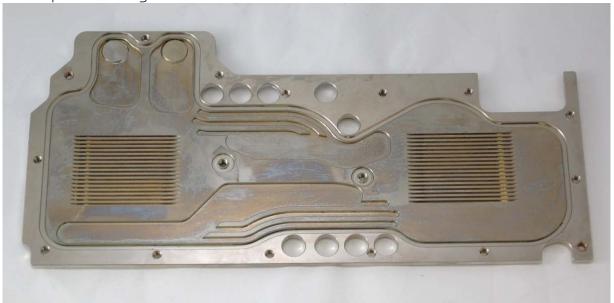
Before partial cleaning:

Only minor stain/discoloration can be seen on the surface, caused by the drying layer of coolant.

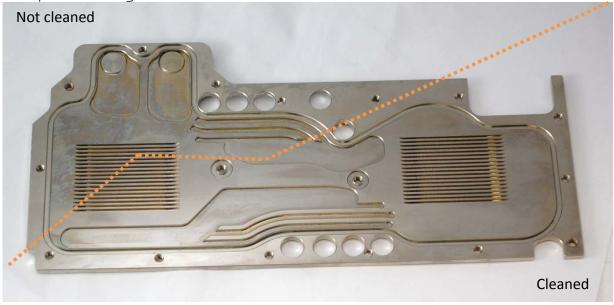
After partial cleaning:

The block was easy to clean with a paper towel, and the original surface gloss was restored. No staining or discoloration remained after wiping.

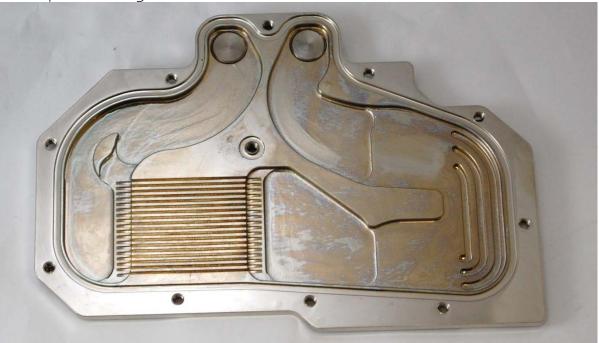
Before partial cleaning:

The dirt on the surface on the nickel plating was mainly dried coolant.

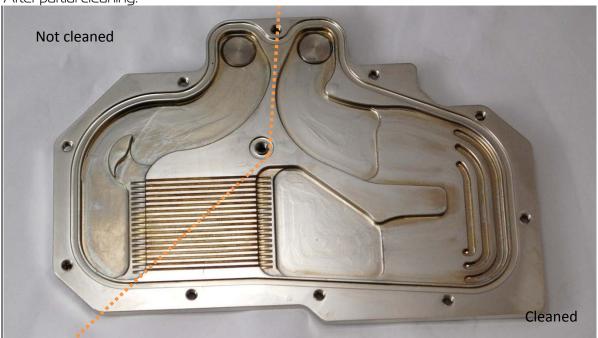
The block was easily cleaned with a paper towel, and the original surface gloss was restored. No staining or discoloration remained after wiping.

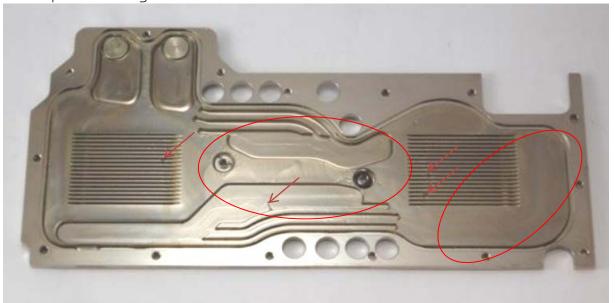
Before partial cleaning:

No excessive dirt/discoloration was found on the surface. However, we have found traces of gunking which appears to be plasticizer from the tubing (see red arrows).

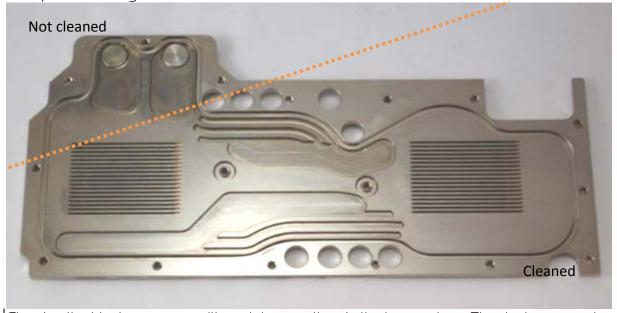
After partial cleaning:

Cleaning the block was easy, although less so than in the loops where Ekoolant was used.

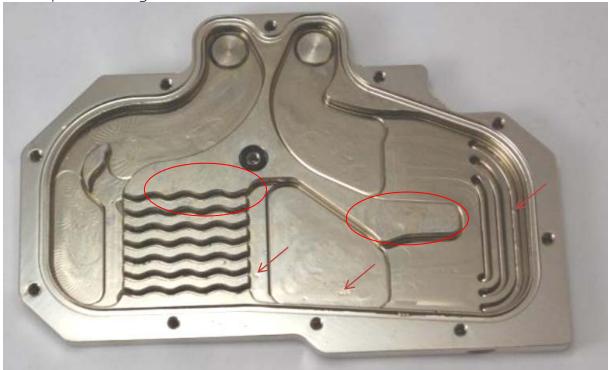
Before partial cleaning:

There was no excessive staining/dirt deposits found. However, we have found traces of gunking which appears to be plasticizer from the tubing.

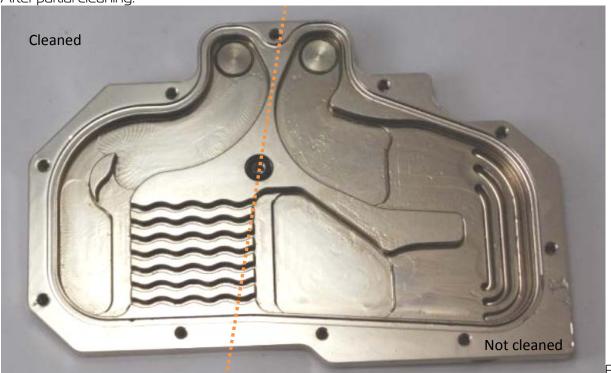
Fluid XP does not leave excessive marks. Cleaning was easy with paper towel.
