*Irregularities on the surface of water-cooling blocks*

*To find reason(s) for the damage to a water-cooling block using the appropriate methods*

# Analysis of the irregularities on the surface of water cooling blocks

EKWB d.o.o., Pot za Brdom 100, SI-1000 Ljubljana

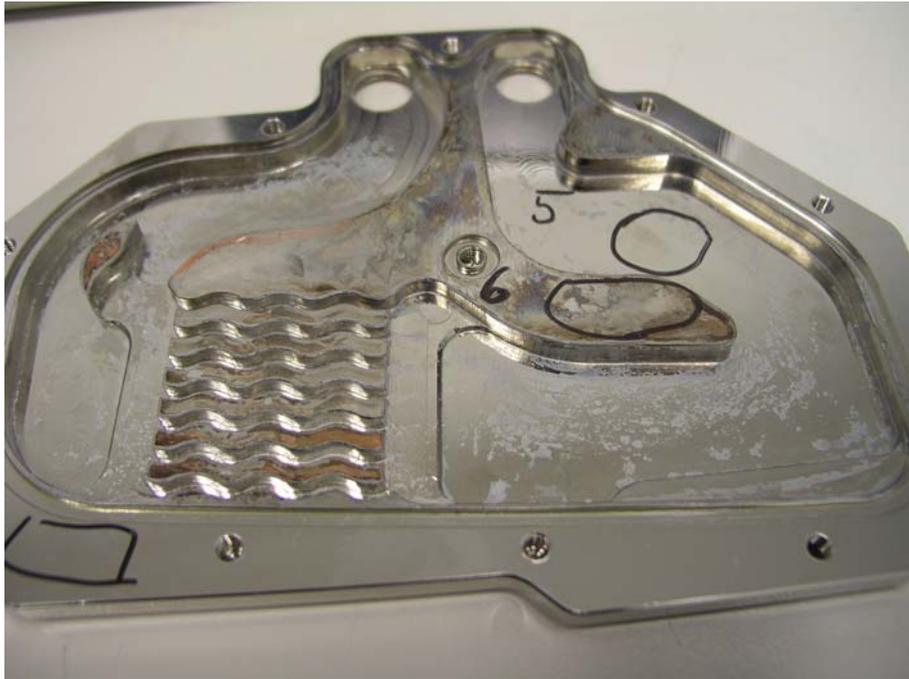
An EK FC470-GTX nickel-plated copper block for the water cooling of computers exhibited a problem with the nickel-plating vanishing, thus exposing the copper underneath. The fluid used in the water-cooling system was distilled water, and a bulk silver coil was used to inhibit algae growth. The process occurred on the surfaces that are close to the plexi-glass top of the block. Additionally, a whitish deposit was formed on the surfaces of the block's chamber (Fig. 1–3).

**Figure 1: Image of the analyzed water-cooling block.**

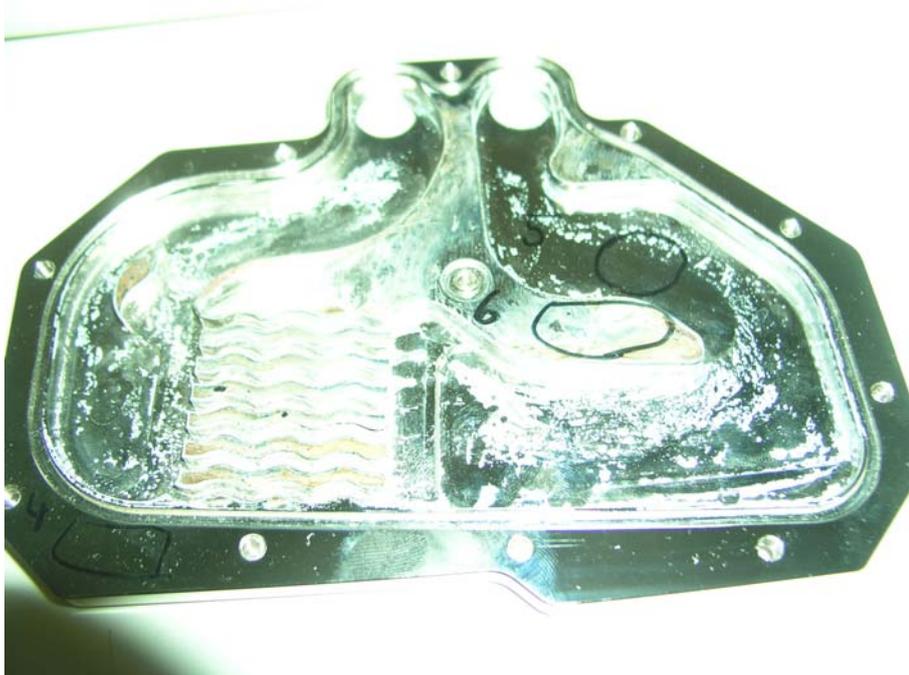
**Figure 2: Whitish deposits on the surface of the block's chamber.**

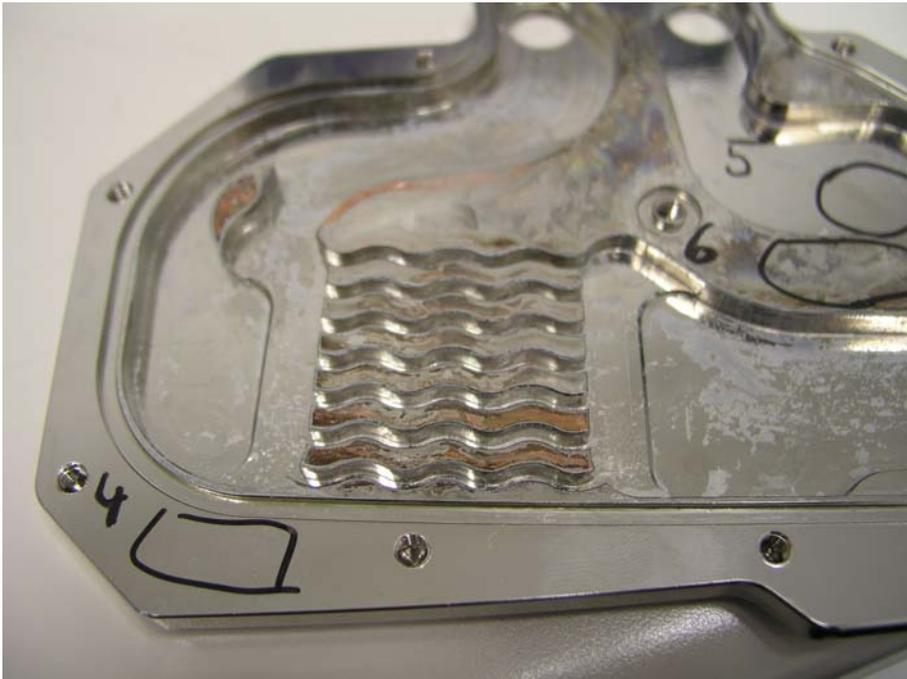
**Figure 3: Exposed copper on the surfaces close to the plexi-glass top of the block.**

Regarding the investigated nickel-plated copper block, the first signs of changes were detected on the surfaces close to the plexi-glass top of the block. In these areas the water is stagnant and the dissolved ions can be concentrated and deposited, leading to a different concentration of oxygen or acids. First, only deposits of different colors were observed. Such

behavior could indicate crevice corrosion due to a locally changed chemistry. Subsequently, the nickel coating completely vanished and the copper metal with its distinctive color was observed. Once the copper is exposed all the conditions for galvanic corrosion between the copper and the nickel are fulfilled, and moreover, the overall corrosion process is strongly accelerated.

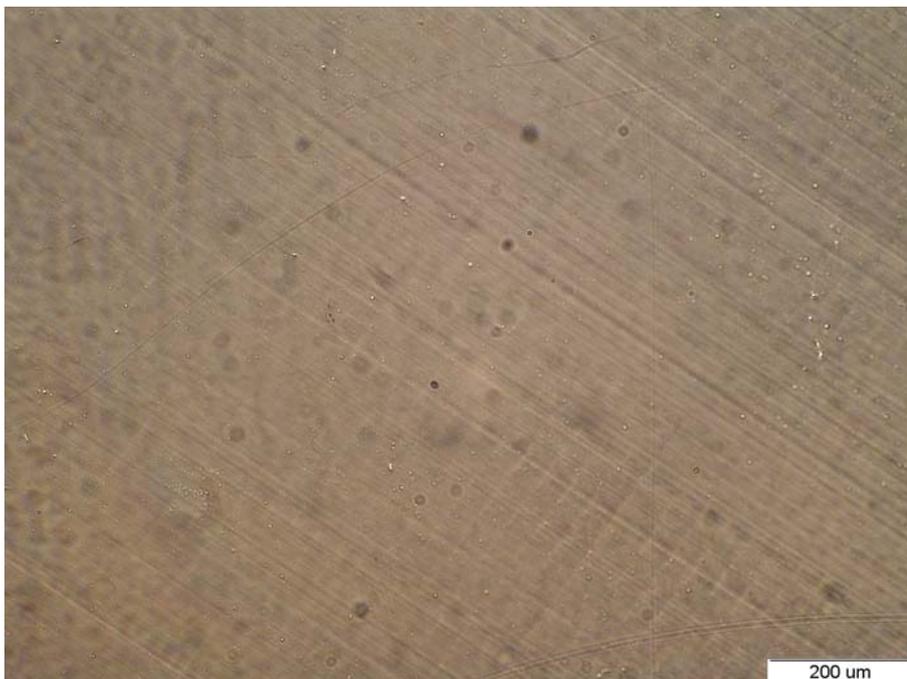
First, the surface of the block that was not in contact with the cooling medium was inspected (Fig. 4). There were no visible defects in the nickel plating; the surface was completely covered with nickel. The surface roughness of the copper base was also maintained for the nickel coating. Fig. 5 shows the edge of the screw hole where the nickel coating was damaged by the screw (made by the customer). The adhesion of the nickel coating is suitable, no peeling or cracking of the coating was detected.

**Figure 4: Surface of the block that was not in contact with the cooling medium.**

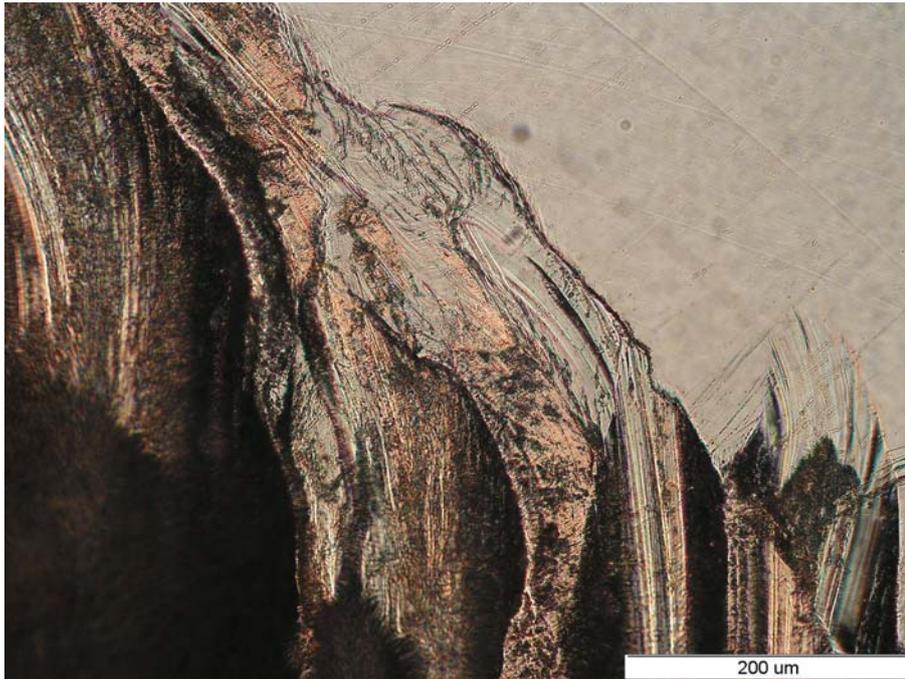
**Figure 5: Scratches on the edge of the screw hole. The colors of the copper and nickel metals can be distinguished.**

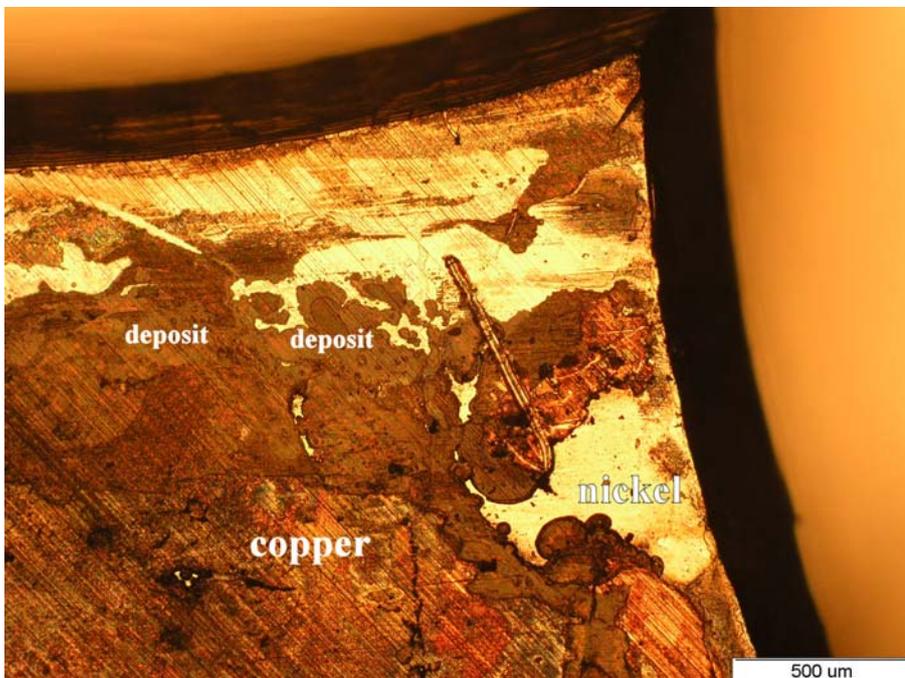
Figs 6 and 7 show the upper surface of a cooling rib, which is close to the plexi-glass cover of the block. Besides the nickel coating (bright) and the exposed copper (red-brown color), a deposit covering part of the surface can be distinguished.

**Figure 6: Surface of a cooling rib.**

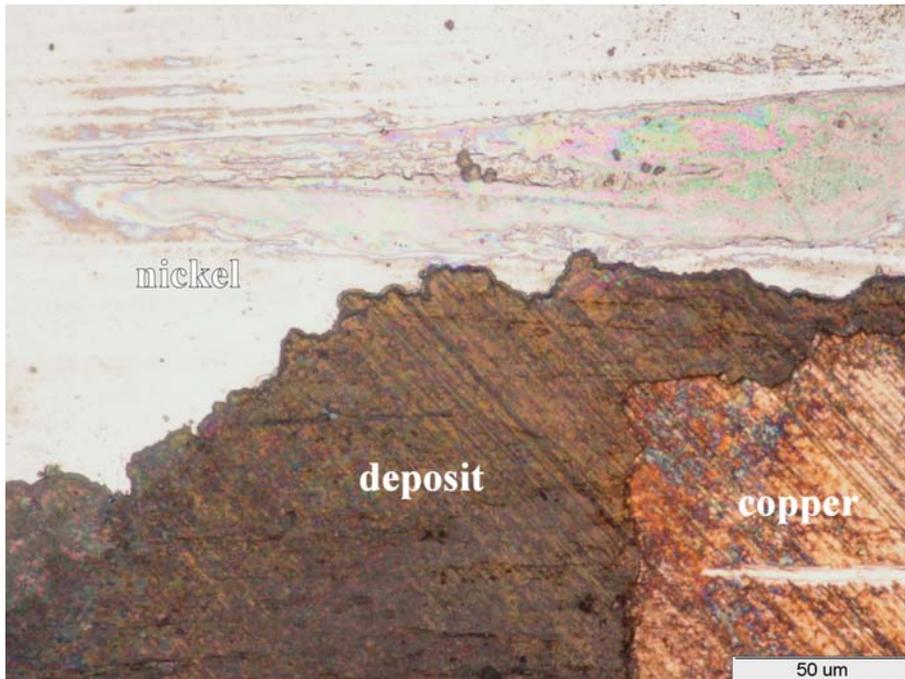
Figure 7: Surface of a cooling rib; higher magnification.

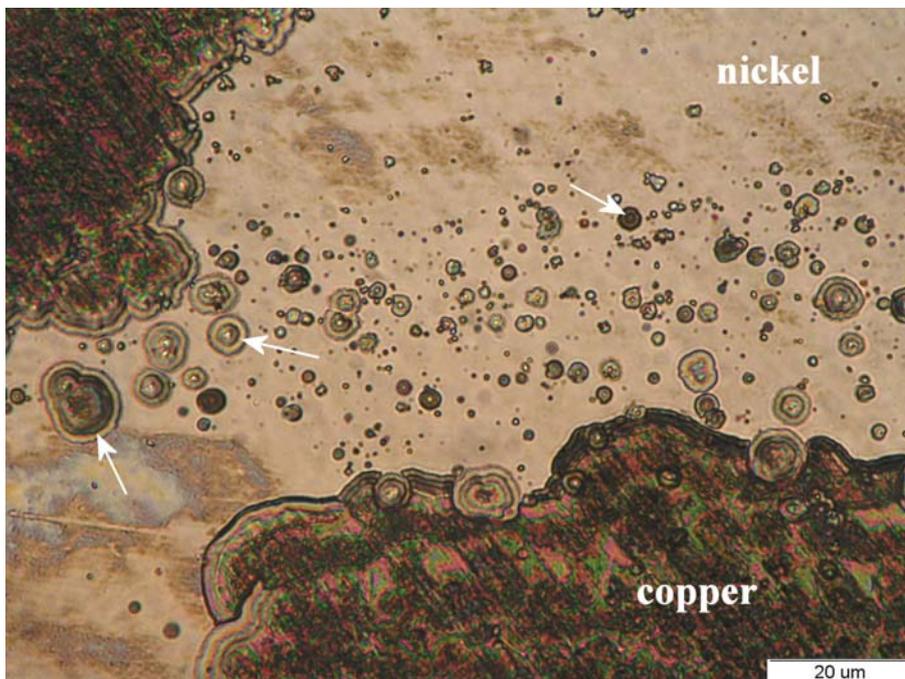
The rounded edges of the nickel/copper boundary (Fig. 8) indicate that the process behind the nickel-coating failure is corrosion. Additional evidence for the corrosion process is the gradual removal of the nickel coating by layers, seen on the nickel/copper boundary (Fig. 9). The peeling mechanism, for which straight cracks in the nickel coating are expected, is excluded.

Figure 8: Corroded nickel coating and exposed copper. New corrosion holes are indicated by arrows.

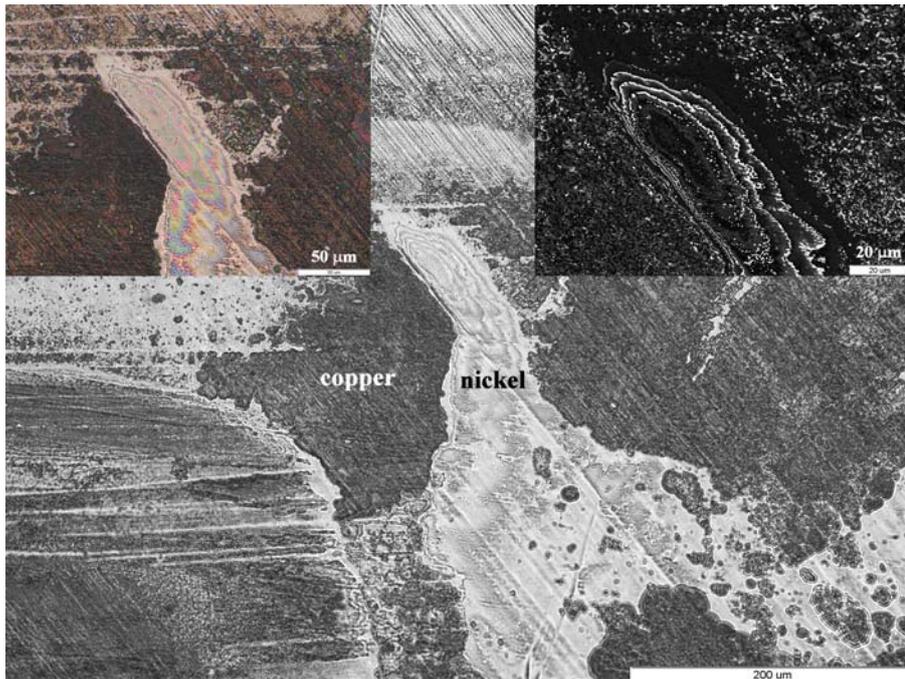
Figure 9: Island of nickel coating exhibiting gradual corrosion of the nickel layers.

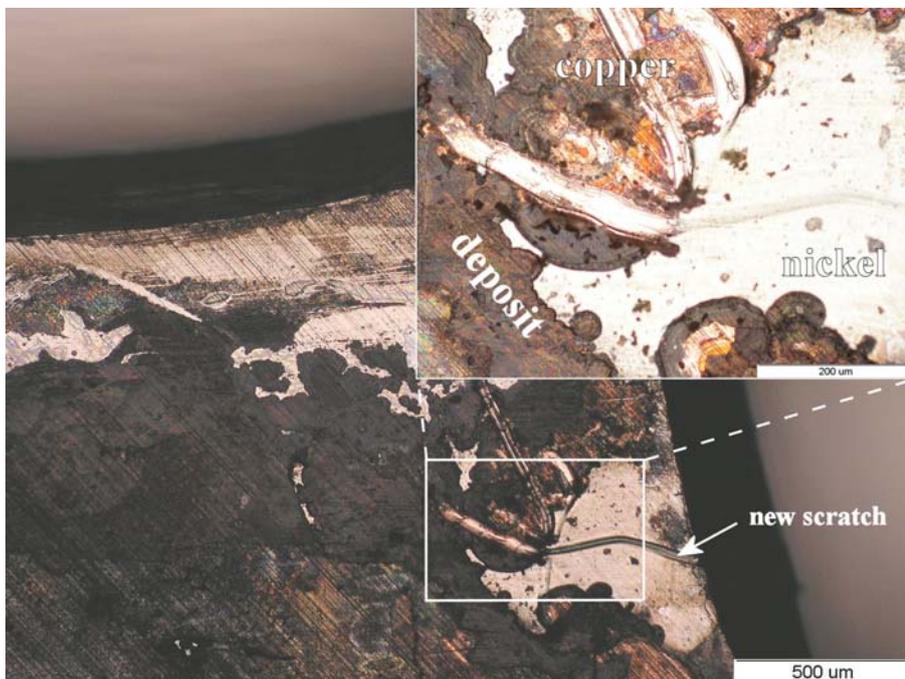
The adhesion of the nickel coating near the corroded surface was checked with fine pincers. A scratch was made from the copper to the nickel (Fig. 10). No cracking of the nickel coating was observed. However, cracking of the deposit can be clearly seen in Fig. 11. Such behavior is expected, since the deposit is only physically bound (not chemically) to the surface. Straight cracks can be observed and the deposit is peeling off.

Figure 10: A scratch made by pincers (compare with Fig. 6). The scratch from copper to nickel is continuous and no cracking is observed.

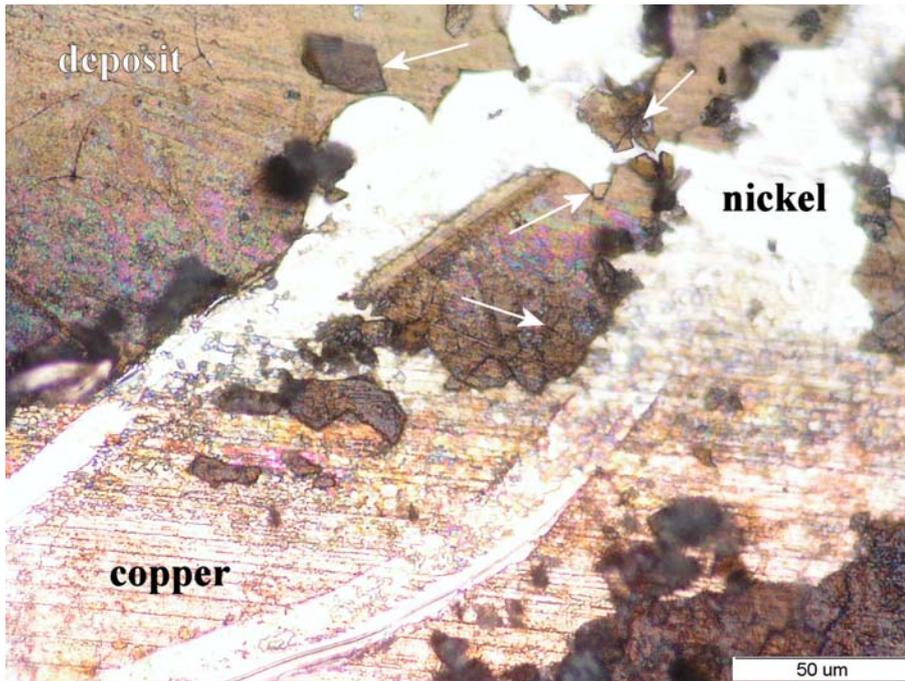
Figure 11: Cracking of the deposit around the pincers' scratch. Some cracks and straight edges are marked by arrows.

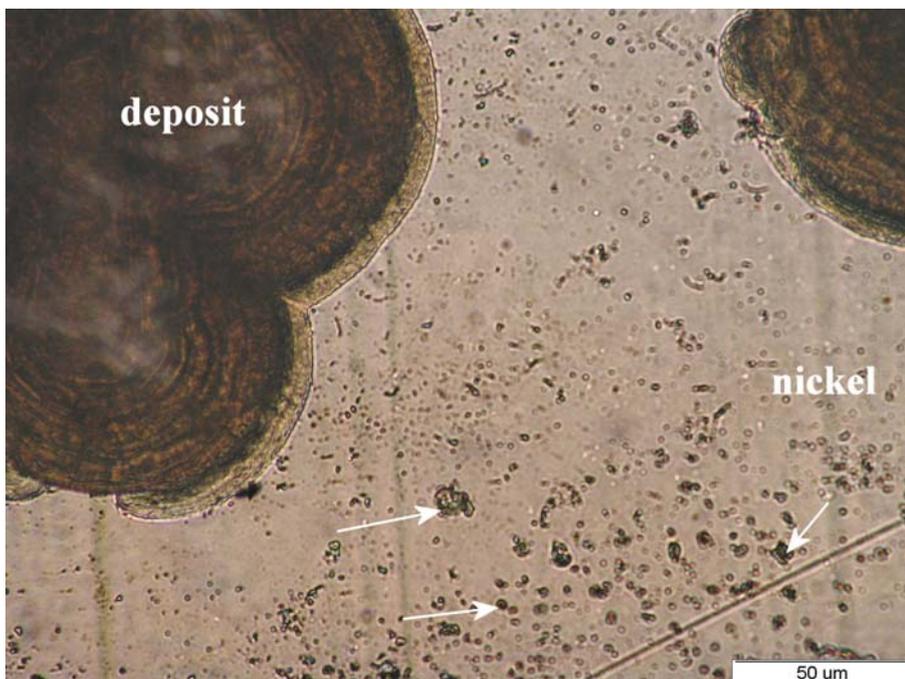
White deposits in the chamber of the water-cooling block are shown in Fig. 12. Small corrosion holes are also visible, indicating that the corrosion process is accelerating and spreading to the less-exposed surfaces. Such behavior is expected due to the higher conductivity of the fluid, since the concentration of the dissolved ions in the closed water-cooling system increases.

Figure 12: White deposits on the nickel coating in the chamber of the water-cooling block. Corrosion holes are indicated by arrows.

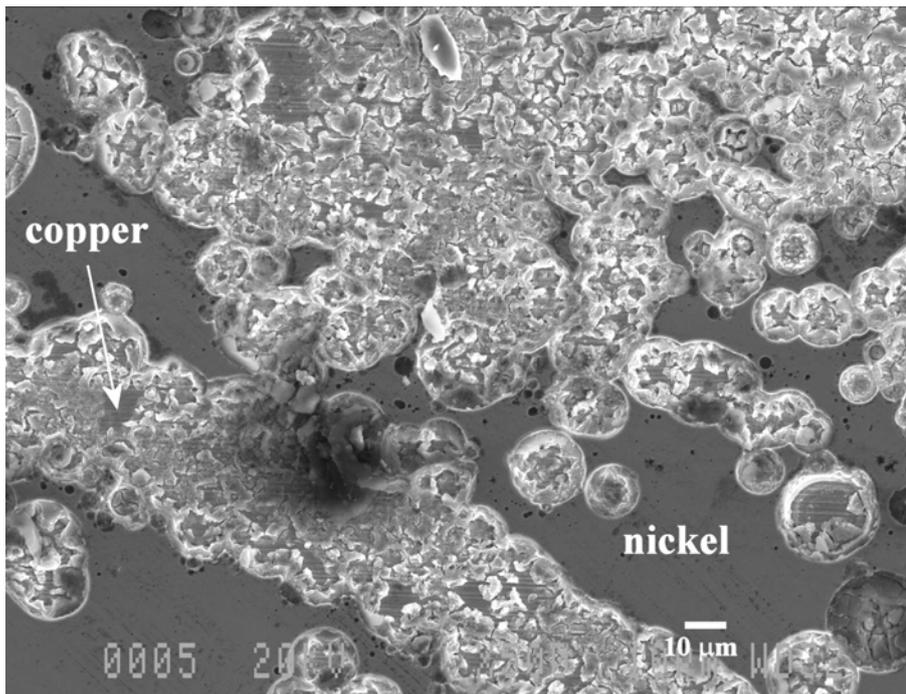
A heavily corroded nickel-coated surface can be seen in Fig. 13. The rounded holes indicate the corrosion process. Within the corrosion holes, the small remaining particles of the nickel coating are losing adhesion with the copper surface. A higher-magnification image of a corrosion hole is shown in Fig. 14.

**Figure 13: Heavily corroded nickel coating.**

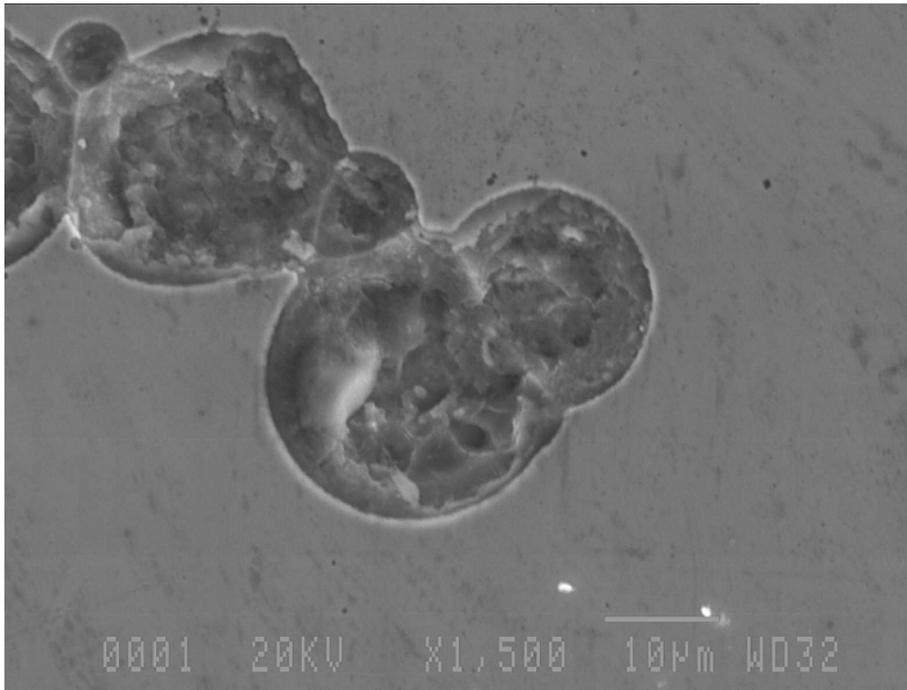
**Figure 14: Corrosion hole.**

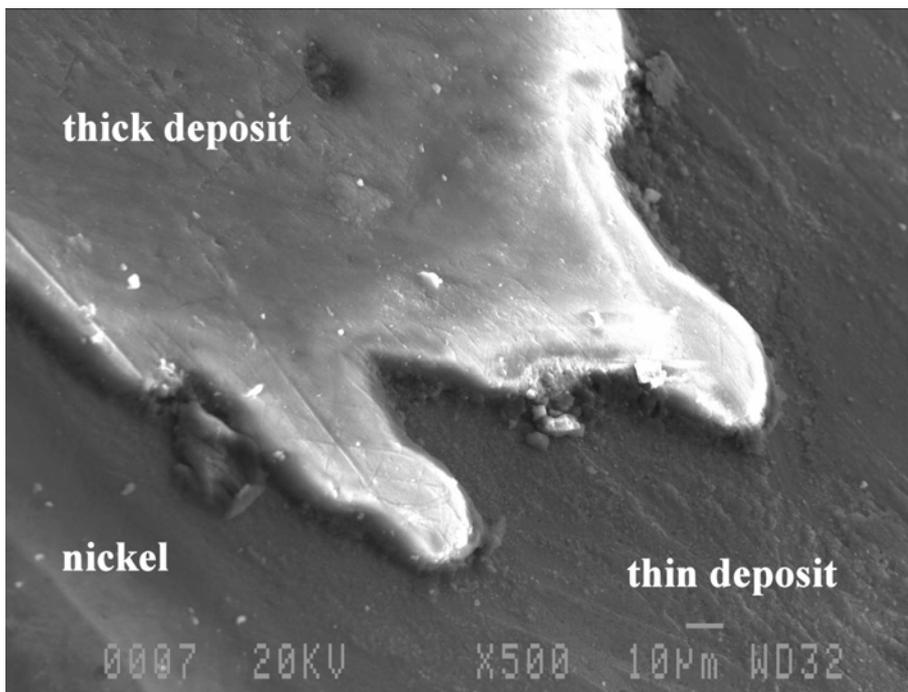
Thick deposits were observed, especially near the edge of the cooling rig (Fig. 15).

**Figure 15: Deposits on the nickel coating.**

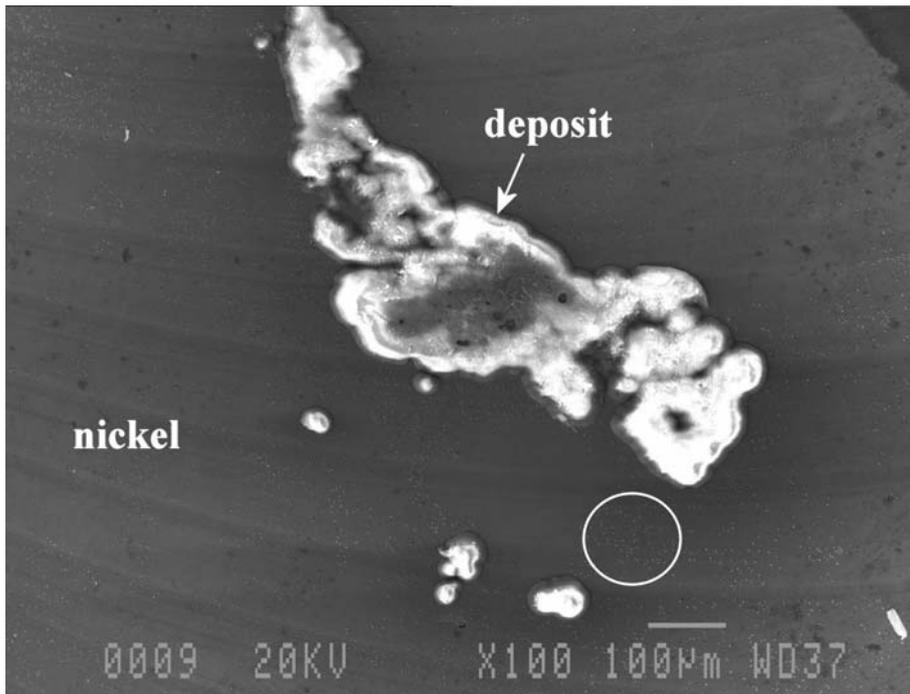
The deposit on the nickel coating in the chamber of the block is shown in Fig. 16. The bright color of the deposit indicates that it is not conductive (oxidized metal(s)). The surface roughness of the machined copper is clearly seen on the nickel coating. The small dots (marked by a circle) on the nickel are the very beginning of the deposits (Fig. 17).

Figure 16: Deposits on the nickel coating in the chamber of the block.

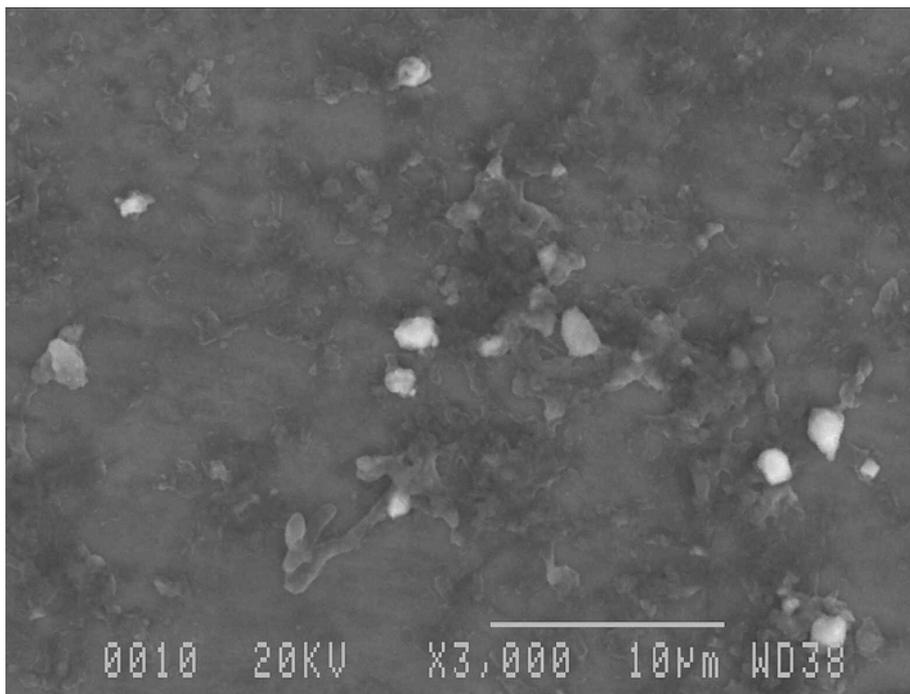
Figure 17: Origins of the deposits (higher magnification of the dots in the circle marked in Fig. 16).

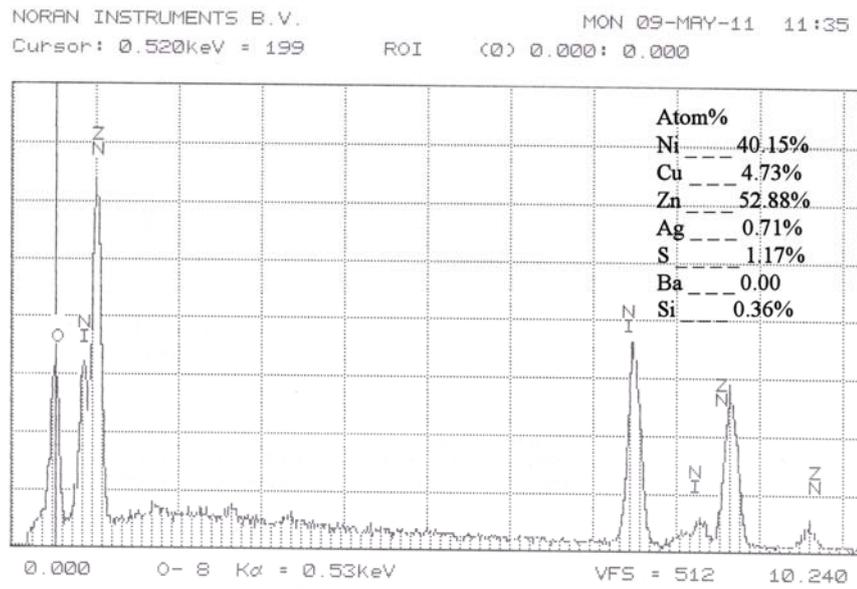
The chemical composition of the deposits is more complex as well as inhomogeneous. Zinc (Zn) is the major constituent of the deposits and it is found in the oxidized form (ZnO), as is clear from Fig. 20. However, additional elements like sulfur (S), silicon (Si), barium (Ba) and silver (Ag) were detected on different spots of the deposits (Fig. 21). The concentration of silver is at the limit of detection. There are additional elements in the deposits; however, their concentration is too low for a proper identification.

Figure 20: EDS spectrum of deposits.

First, the most likely origin of the detected elements in the deposits needs to be discussed. The major constituent of the deposits is Zn, in oxidized form ( $Zn^{2+}$ ), which probably originates from the radiator. The radiators are usually made of brass, the chemical composition of which is a copper/zinc alloy, although some minor additives are added like lead (Pb) or silicon. Silicon could come into the solution either from brass (if it is used as additive) or from grease, which is sometimes used for sticking and waterproofing of different water-cooling system parts. Different barium compounds like Ba-acetates, Ba-chloride or Ba-sulfate, are used in dyes, pigments, paints and lubricating oils. There is no idea as to how exactly the barium has come into the cooling fluid. The same can be said for sulfur; however, it could be some remains, stuck on a radiator after the manufacturing/cleaning process. Silver, the content of which is at the limit of the detection, could come from the silver coil used to inhibit algae growth. Silver ions which are dissolved from the coil are extremely toxic for bacteria and algae, and thus are also efficient in a very small concentration (silver metal is practically insoluble).

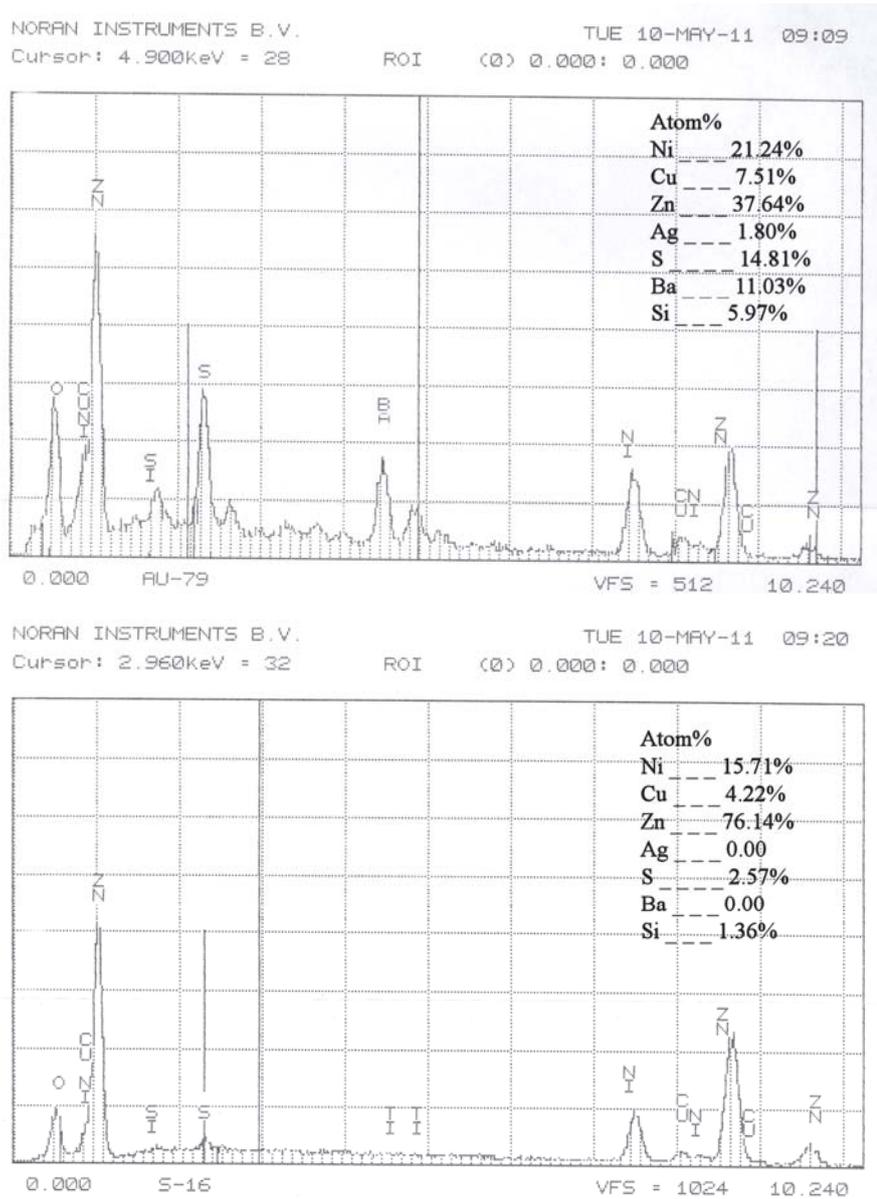
Figure 21: EDS spectra of deposits.

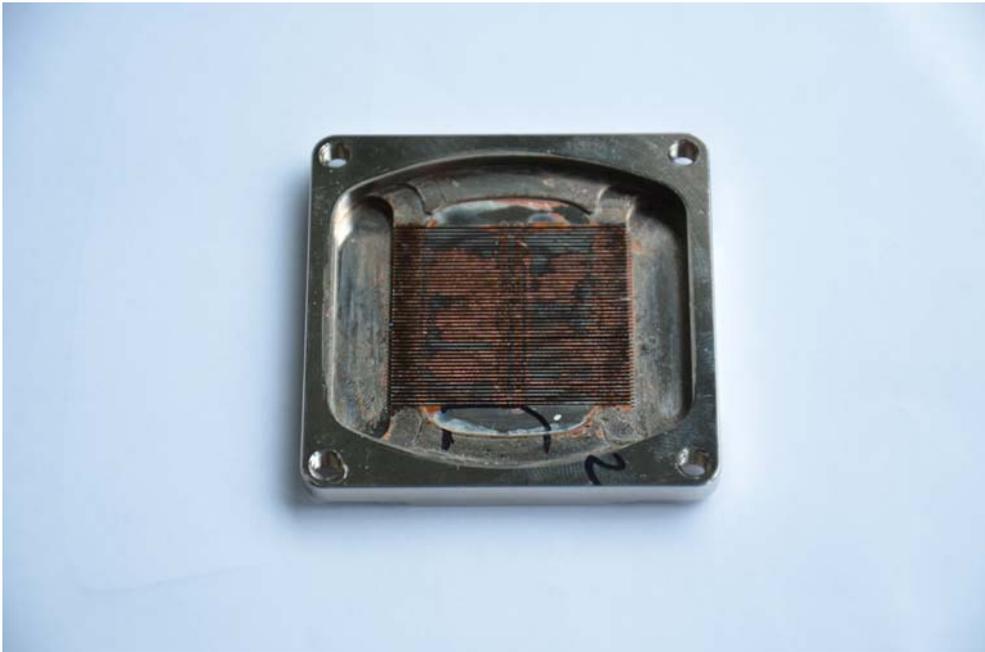
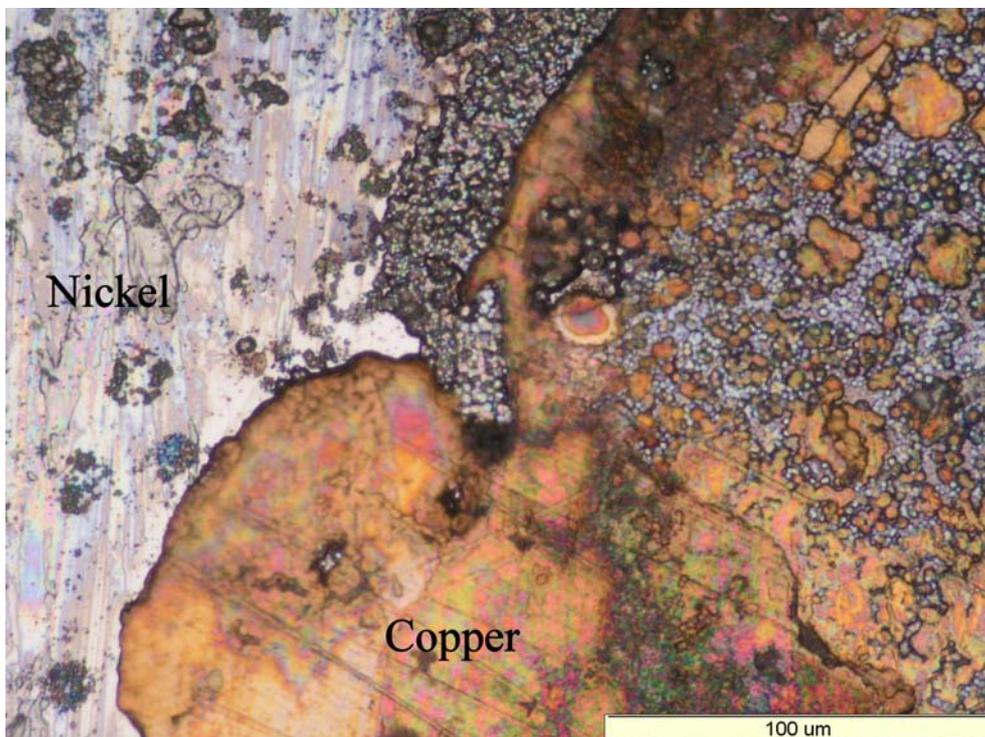
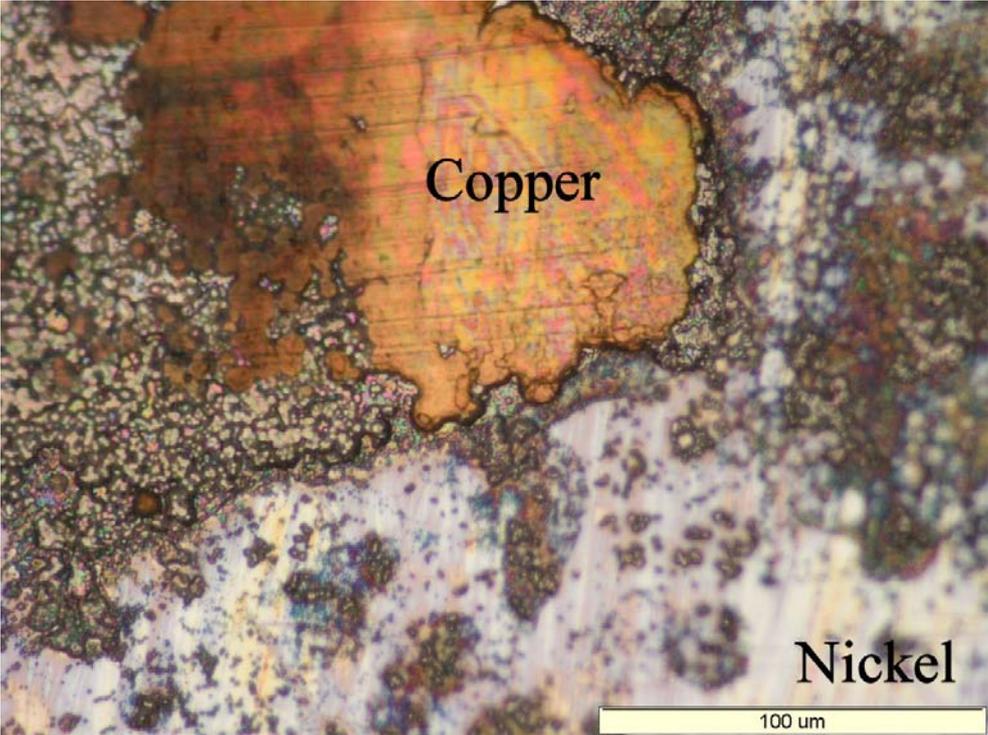
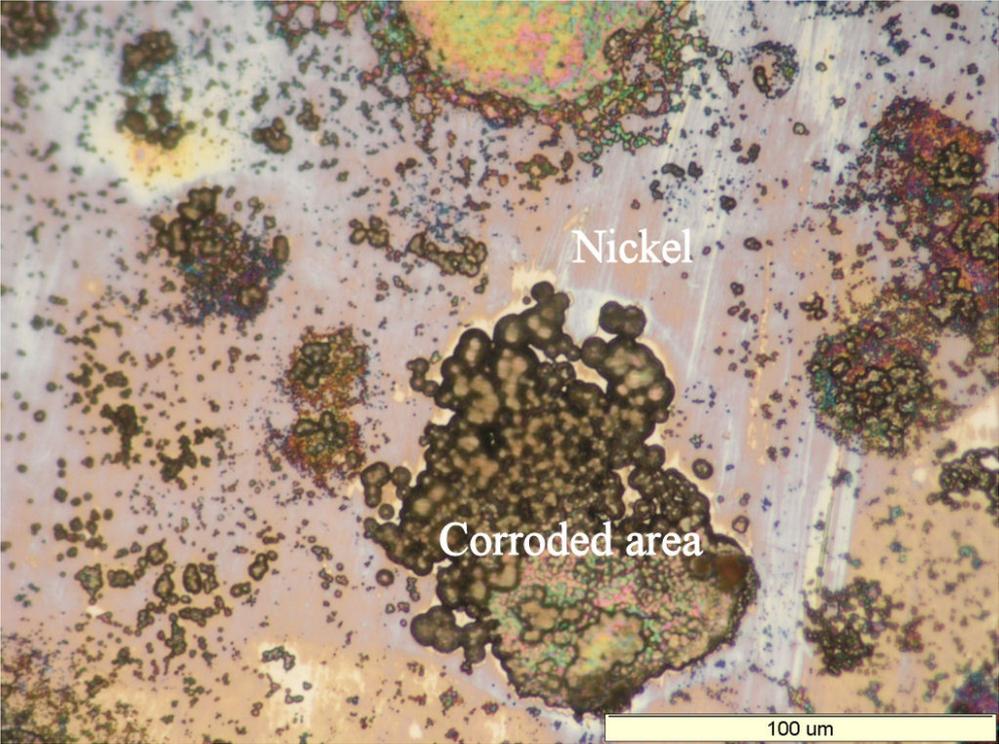
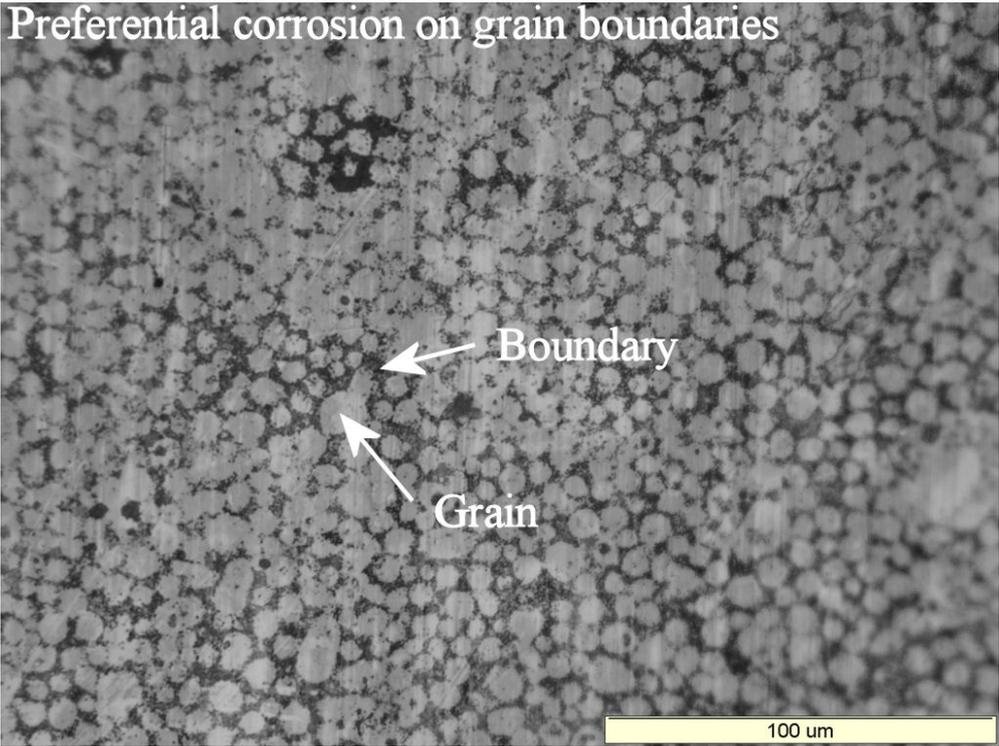
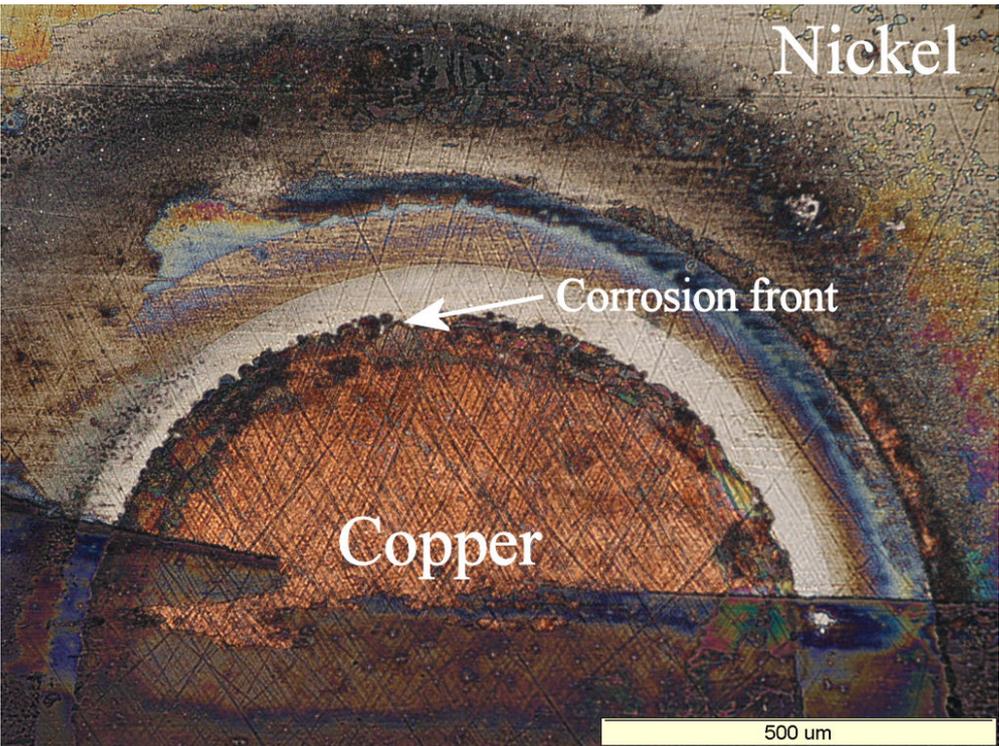
## **Block #2**

On this nickel-plated, copper, water-cooling block the surface is highly corroded. However, no peeling was detected, indicating good adhesion of the nickel coating. Different ways and progress of the corrosion are visible on different surfaces of the block; preferential corrosion starting at the grain boundaries, and semi-circle corrosion. This is due to different liquid velocities in different parts of the block. Selective corrosion occurred at a place with high a liquid velocity, while a semi-circle was produced by stagnant liquid propagating under the contact of nickel and plexi-glass cover.

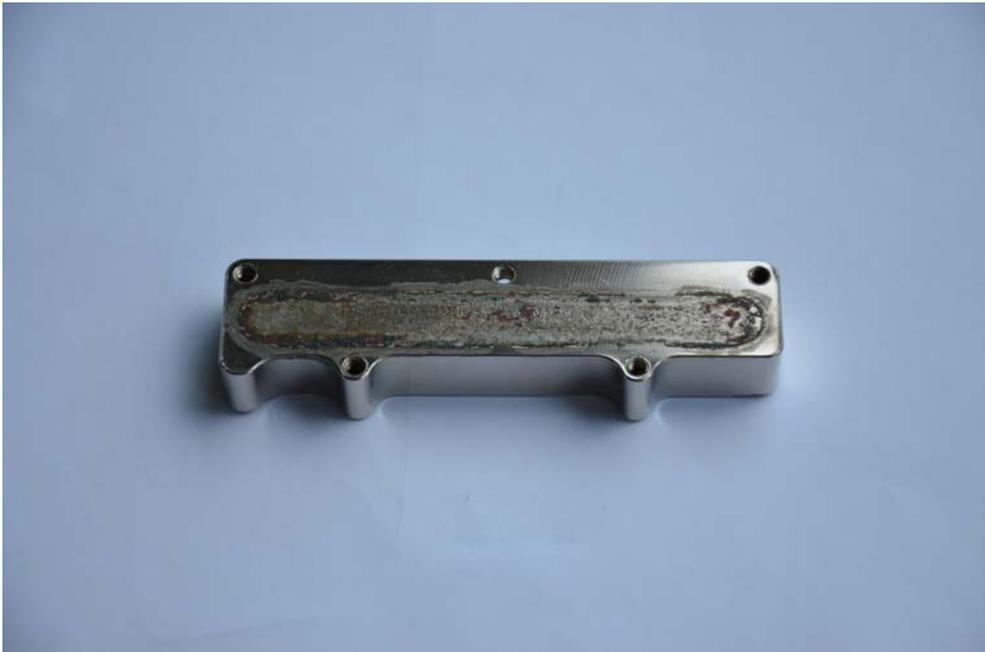
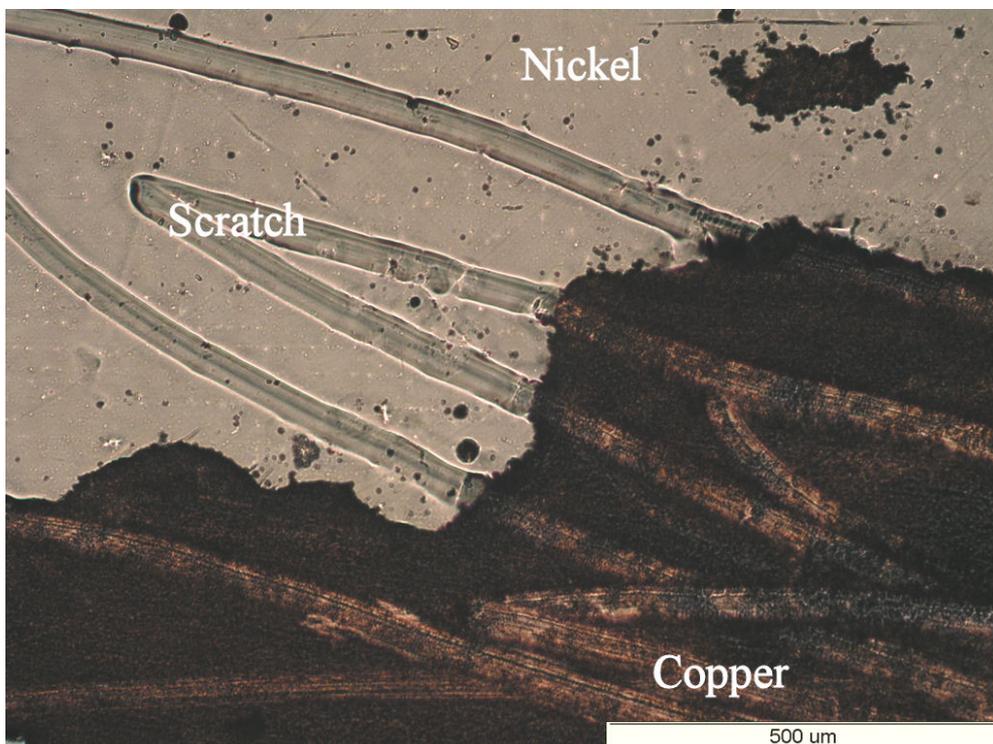
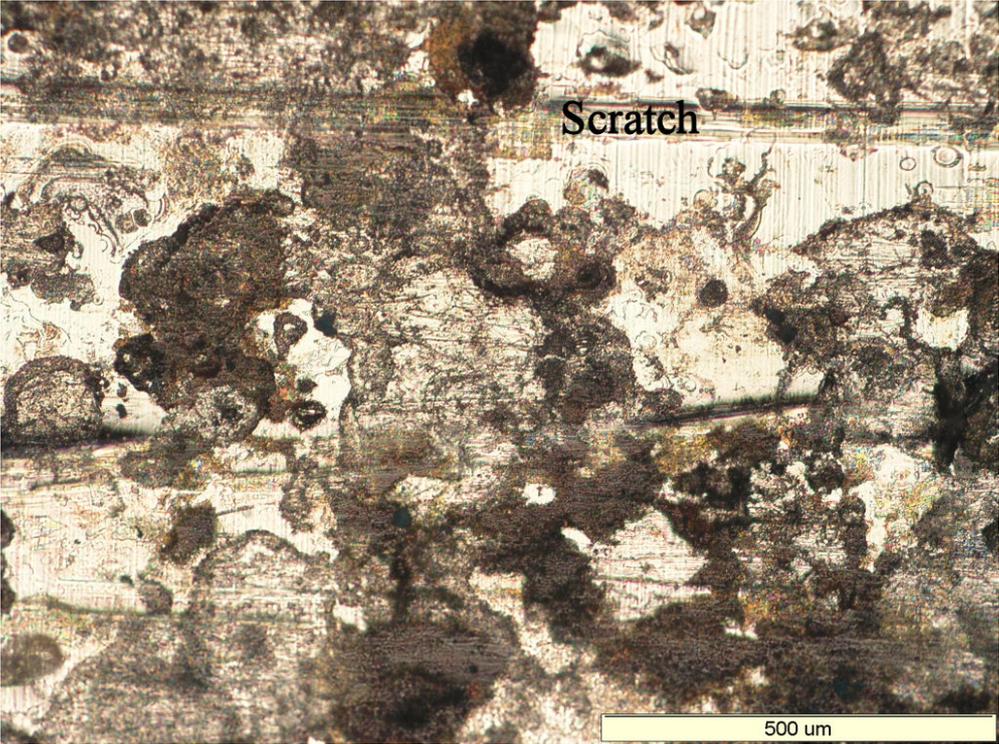
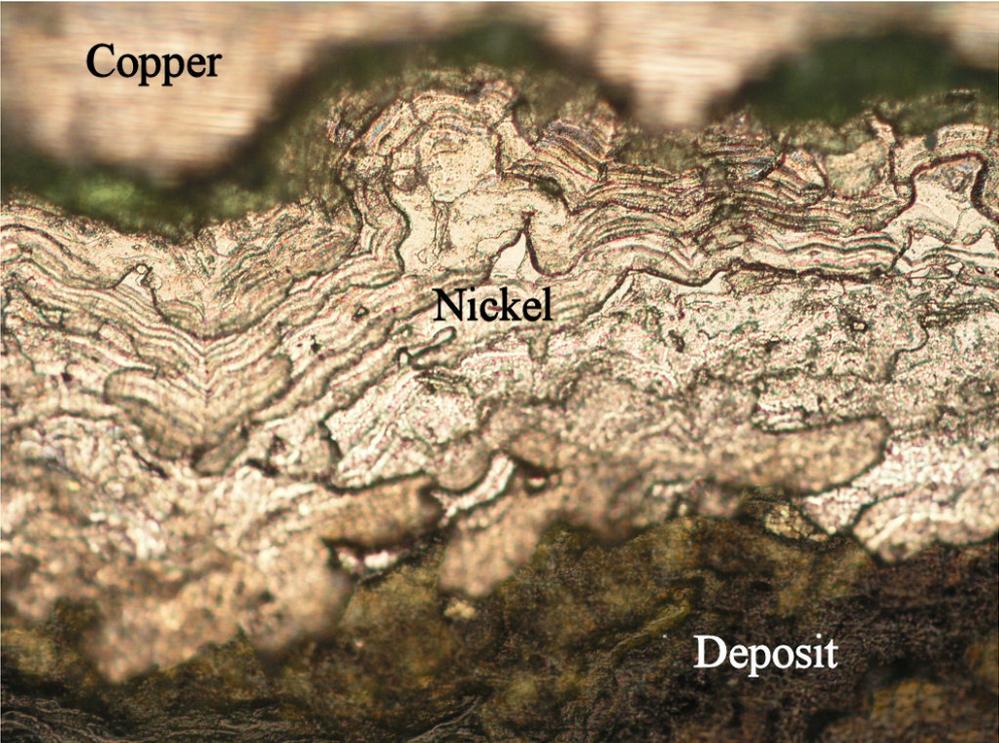
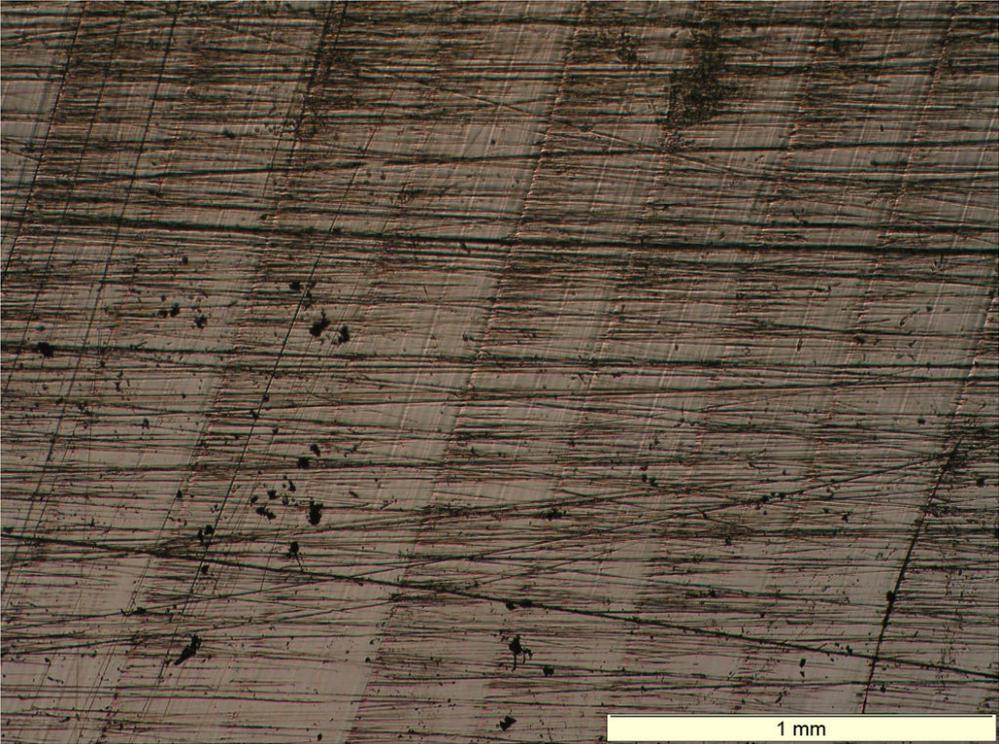
## **Block #3**

In this case there is a highly corroded nickel coating over the whole exposed surface. No peeling was detected, even on the corrosion front line. Pincers' scratches were made to test the adhesion of the coating. In contrast to the above case, a green coloration of the oxidized copper is visible. Such behavior indicates acidity of the cooling liquid, since in a non-acidic medium the copper is protected from oxidation because it is cathodic. The last figure shows scratches on an unexposed surface of the block, indicating cleaning with an abrasive medium.
