*Irregularities on the surface of water-cooling blocks*

*To find reason(s) for the damage to a water-cooling block using the appropriate methods*

# Analysis of the irregularities on the surface of water cooling blocks

EKWB d.o.o., Pot za Brdom 100, SI-1000 Ljubljana

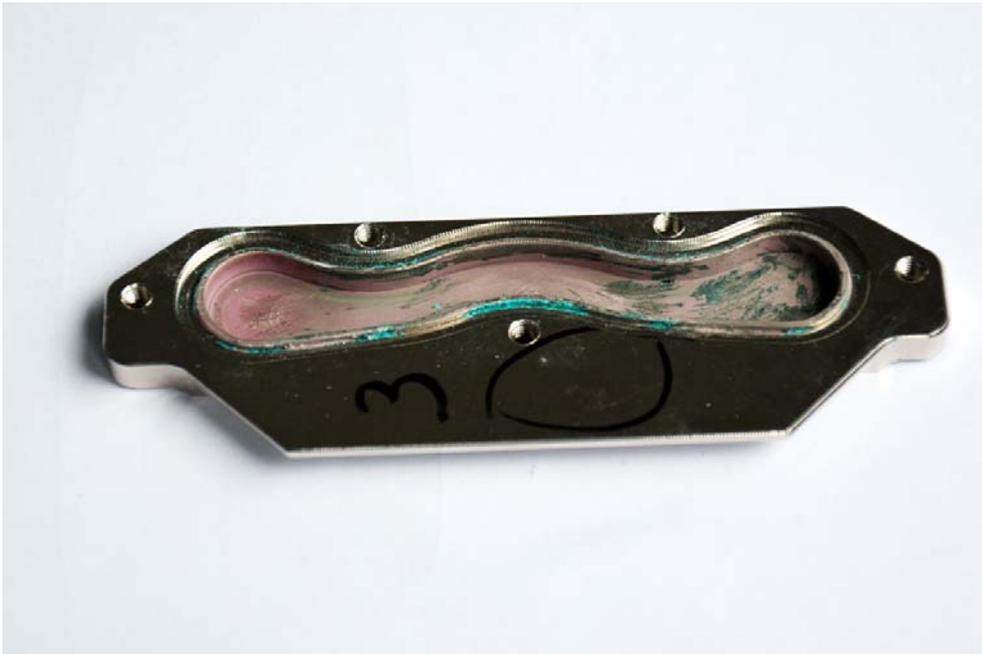
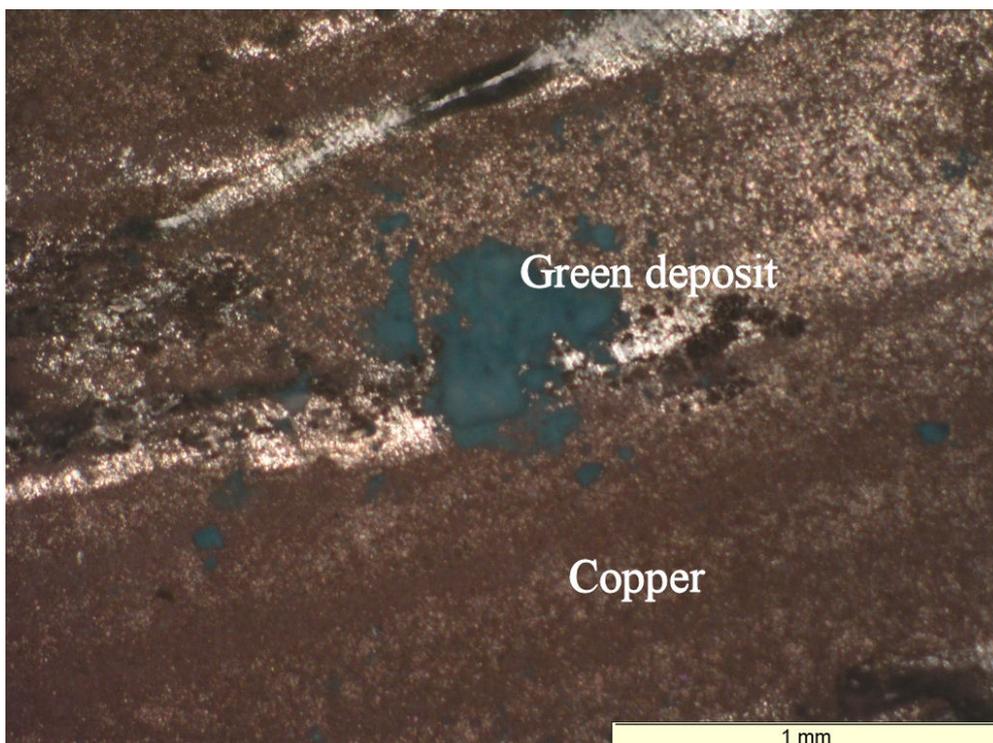
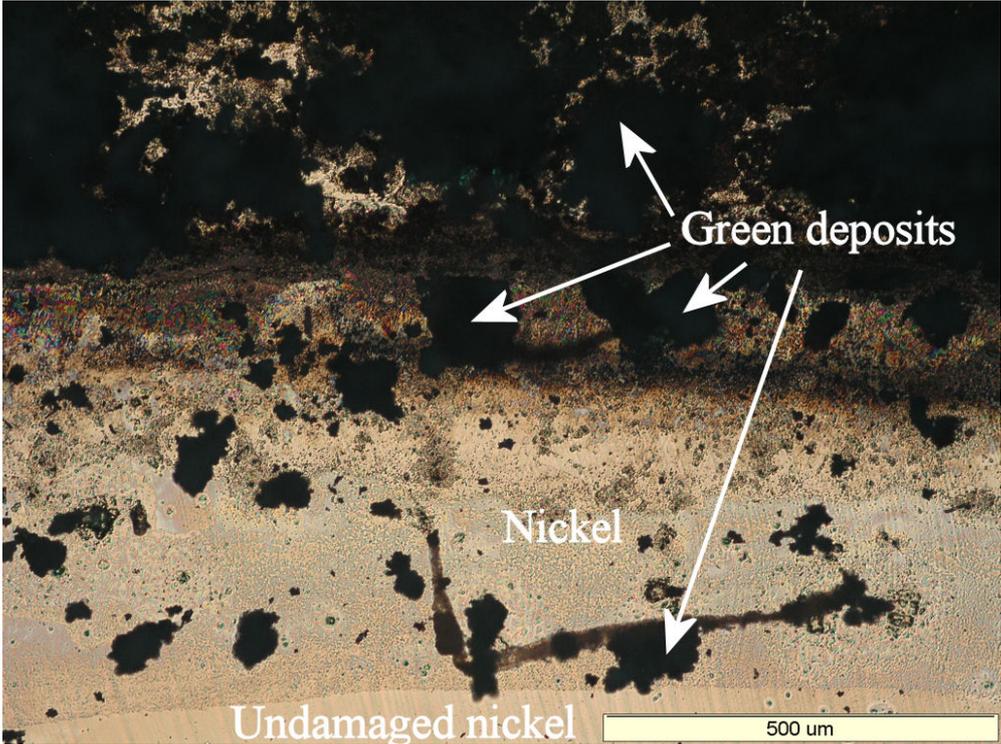
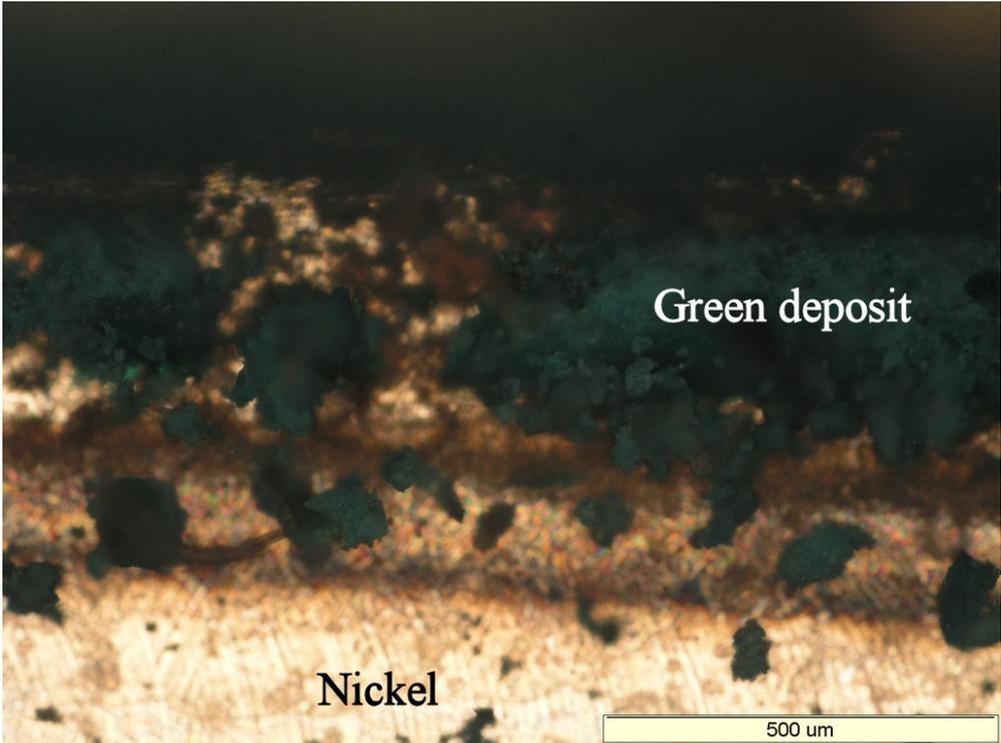
## **Block #4**

Almost all of the nickel coating was removed from the surfaces exposed to the cooling liquid. The green deposits indicate oxidation of the exposed copper due to the acidic environment. The nickel coating behind the sealing is undamaged.

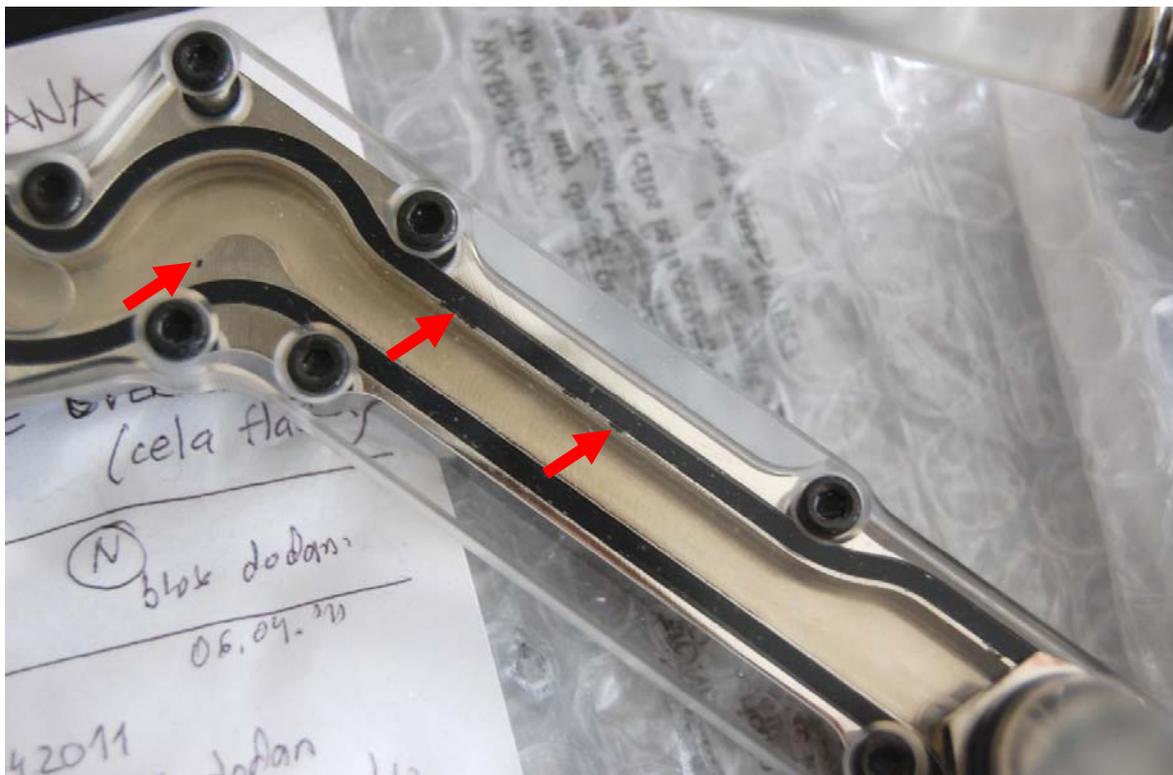
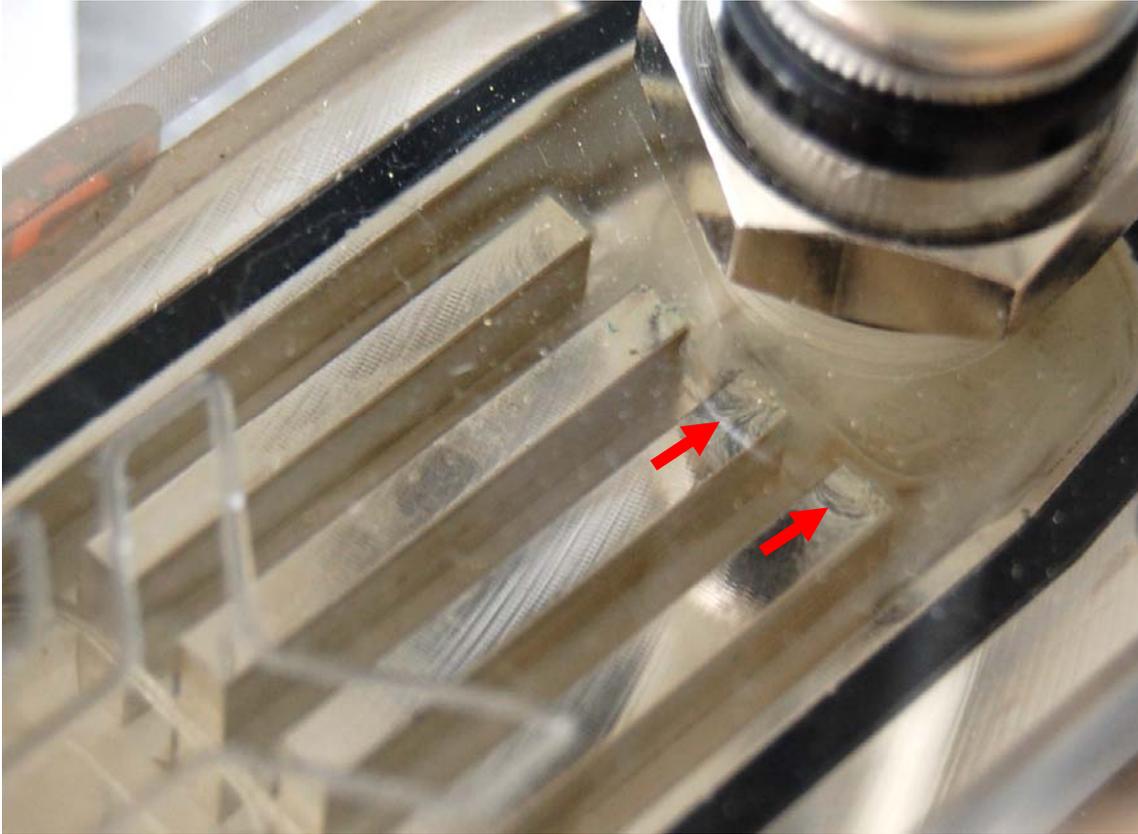
Date: April 28<sup>th</sup>

Observation: First look at nickel corrosion

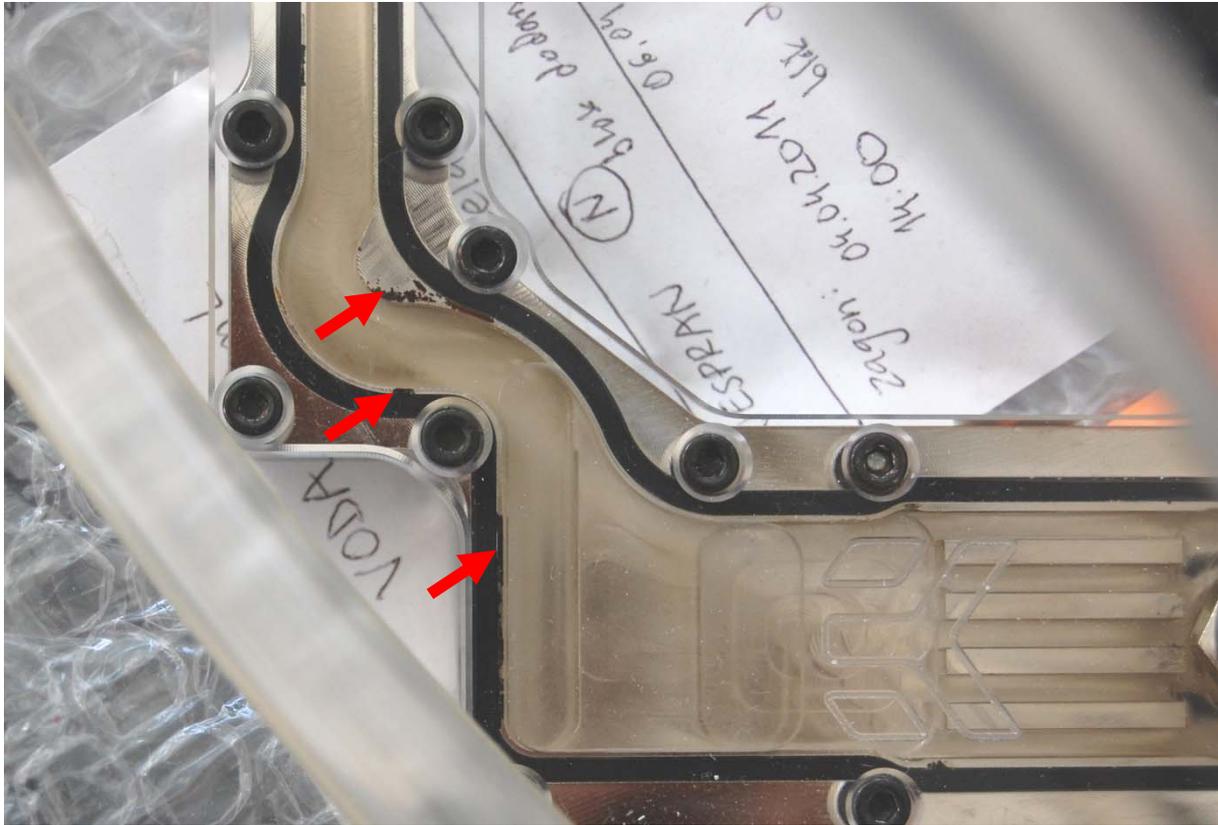
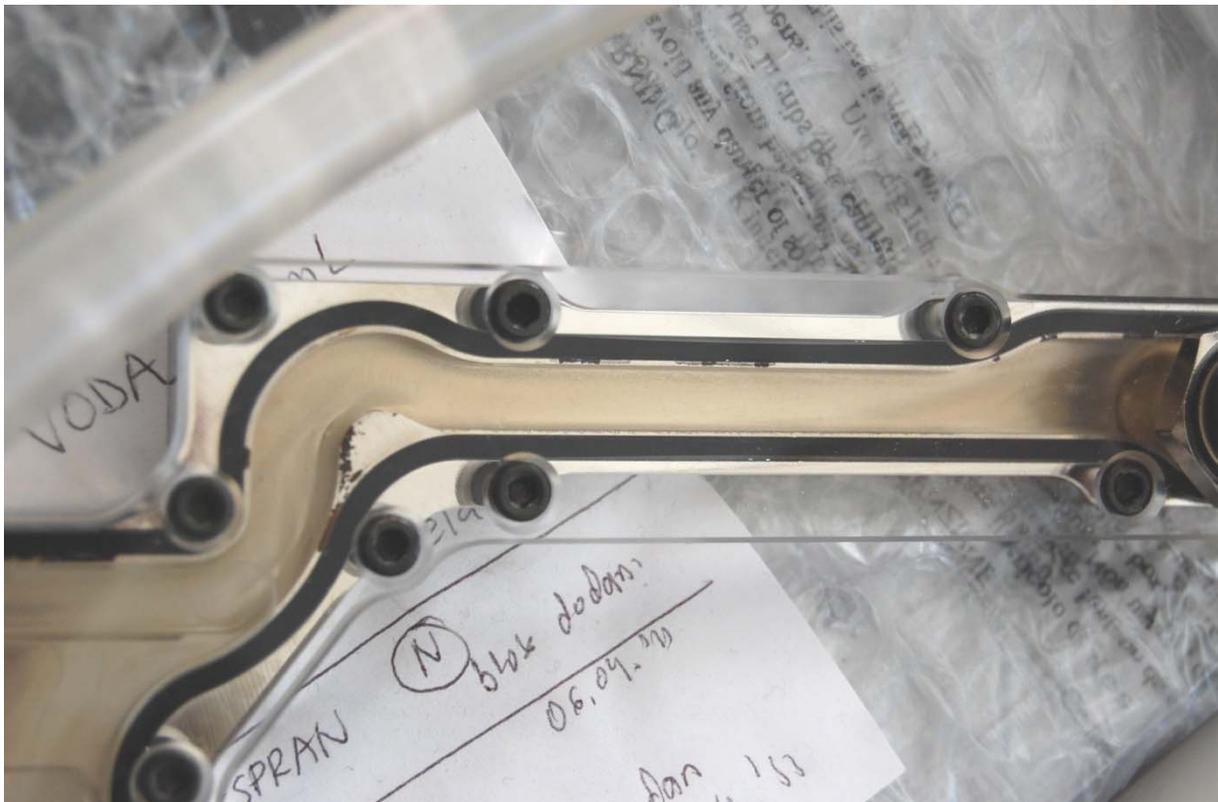
Date: May 17<sup>th</sup>

Observation: Obvious states of corrosion between the water-cooling block and plexi-glass top

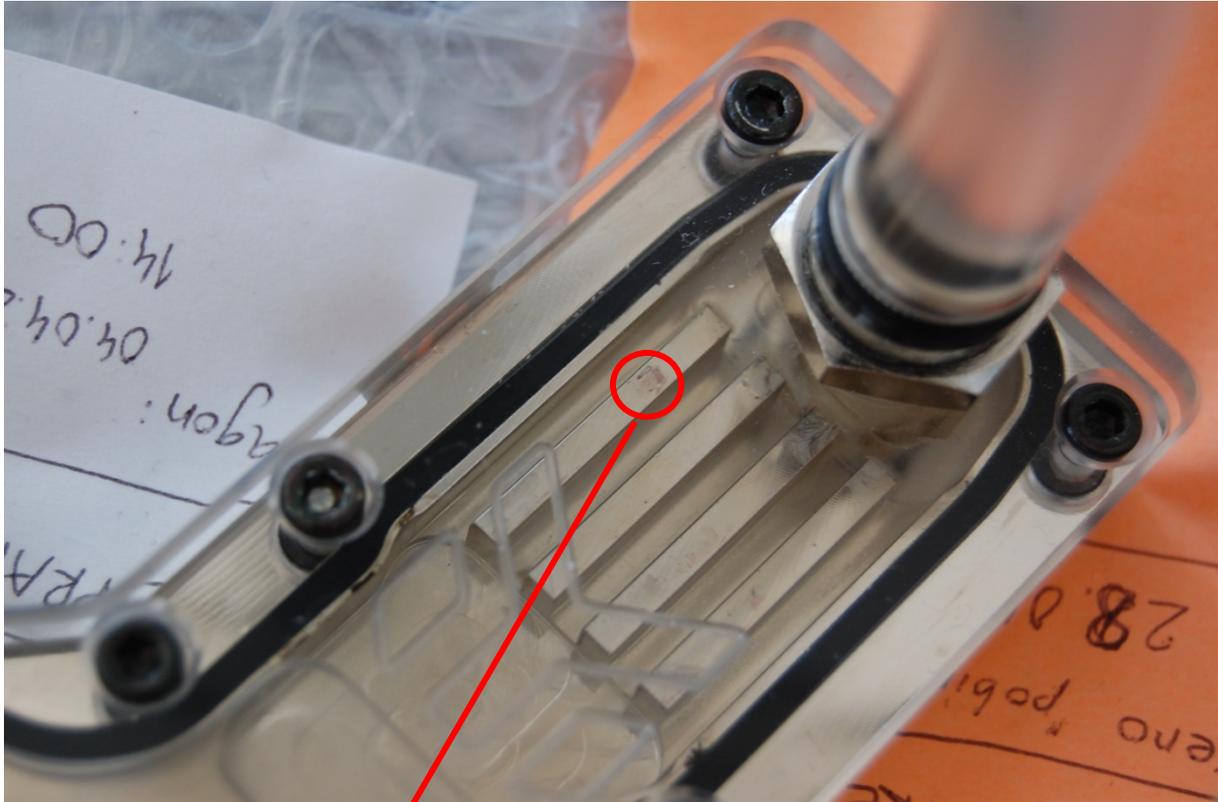
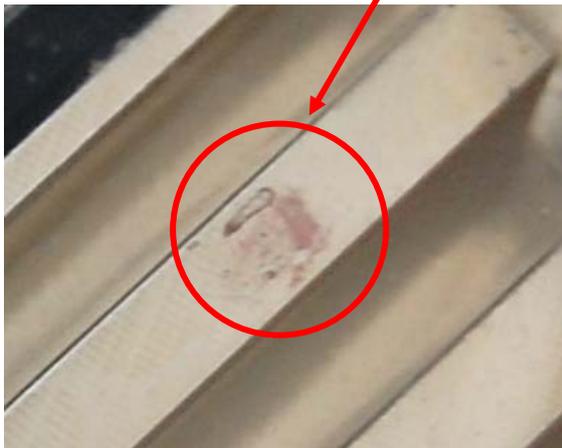
Image of area 1:

Observation: Obvious state of corrosion. Clear copper can be seen where the nickel coating is completely removed.

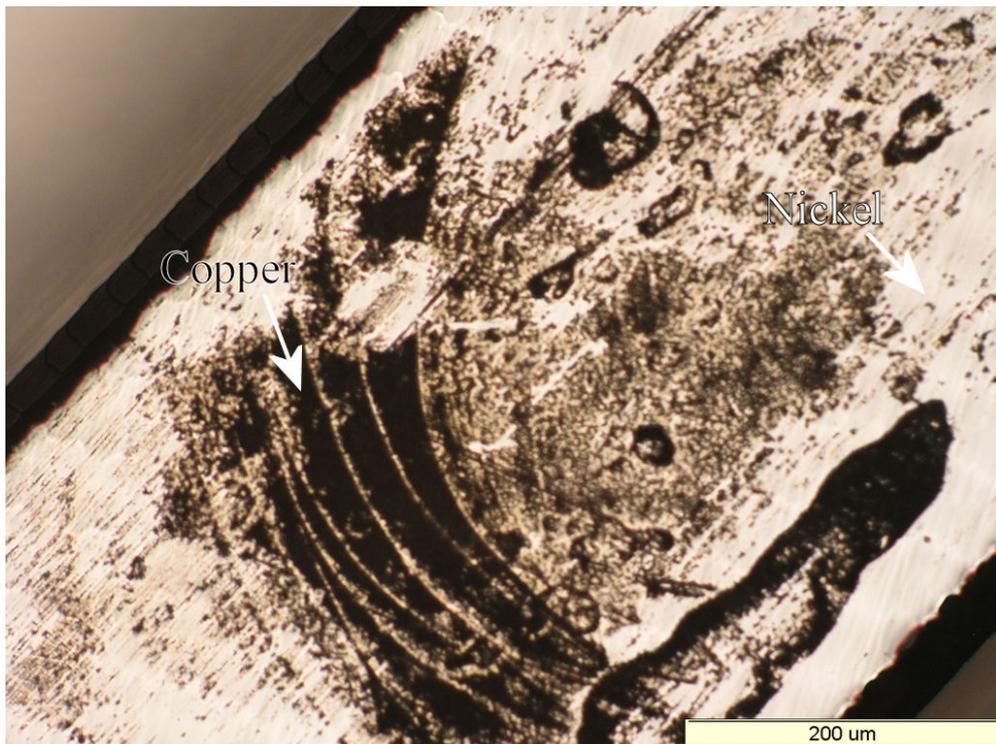
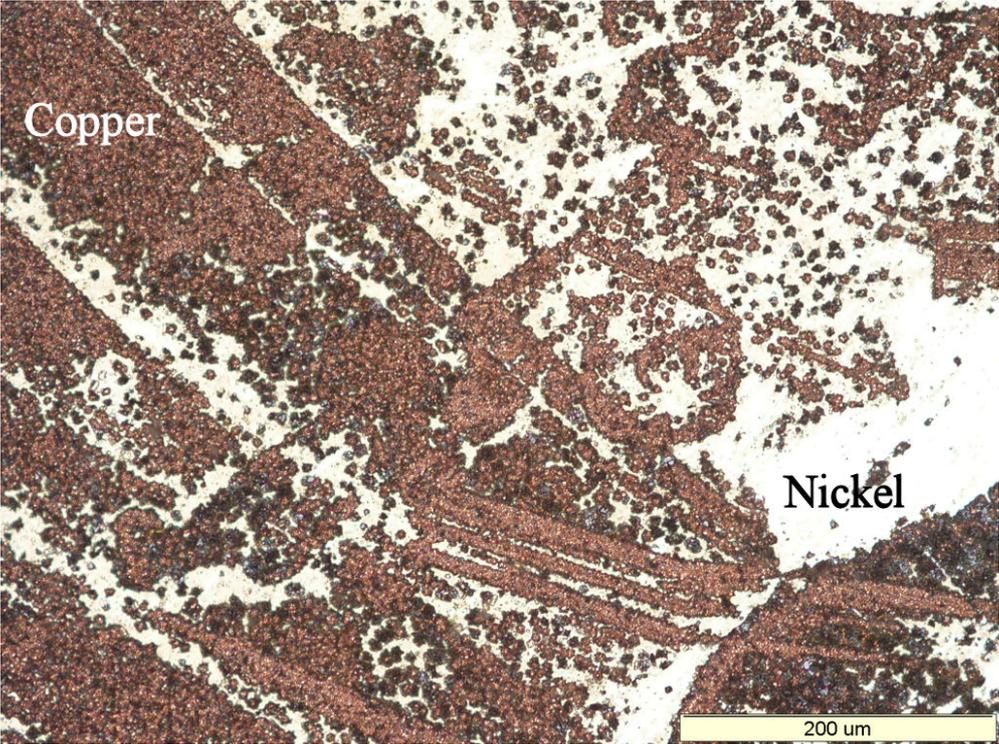
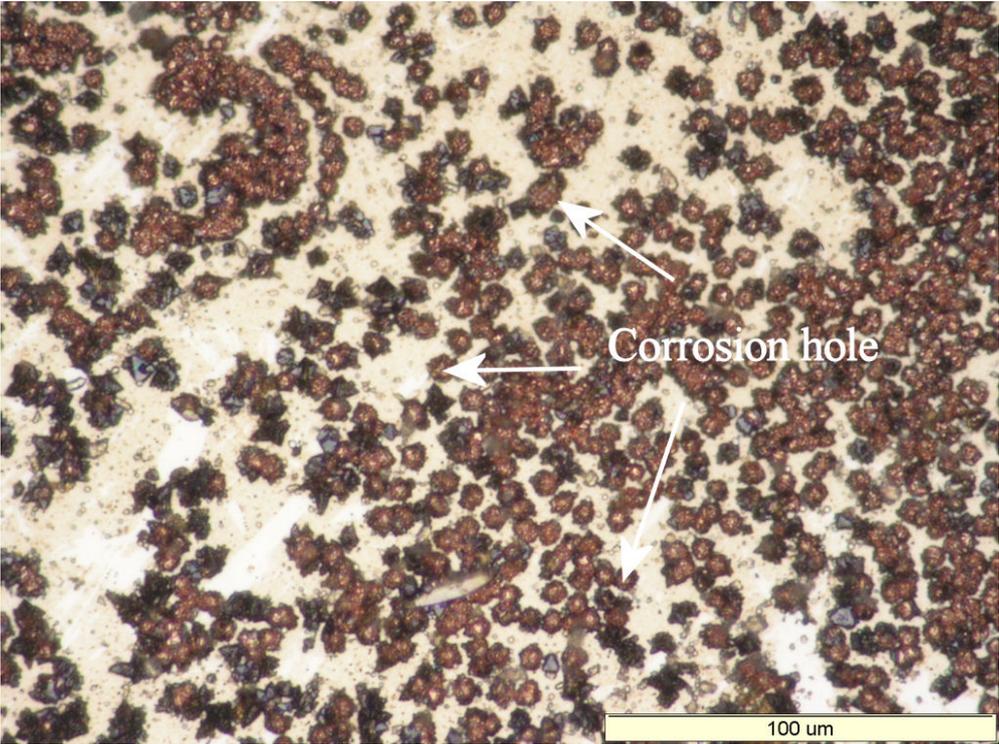
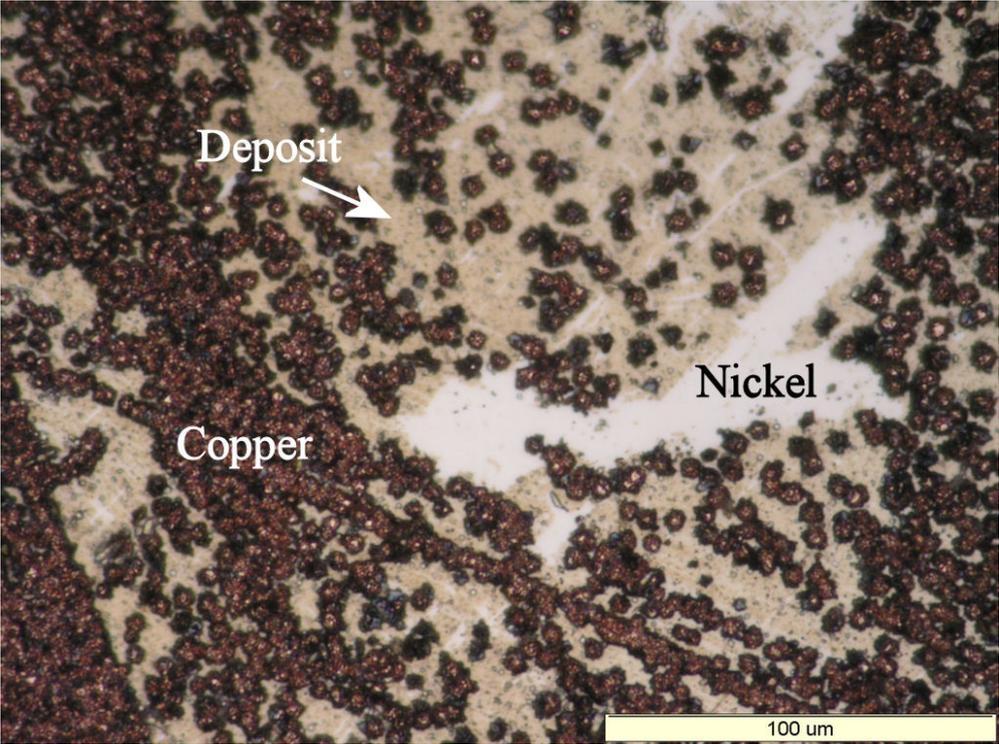
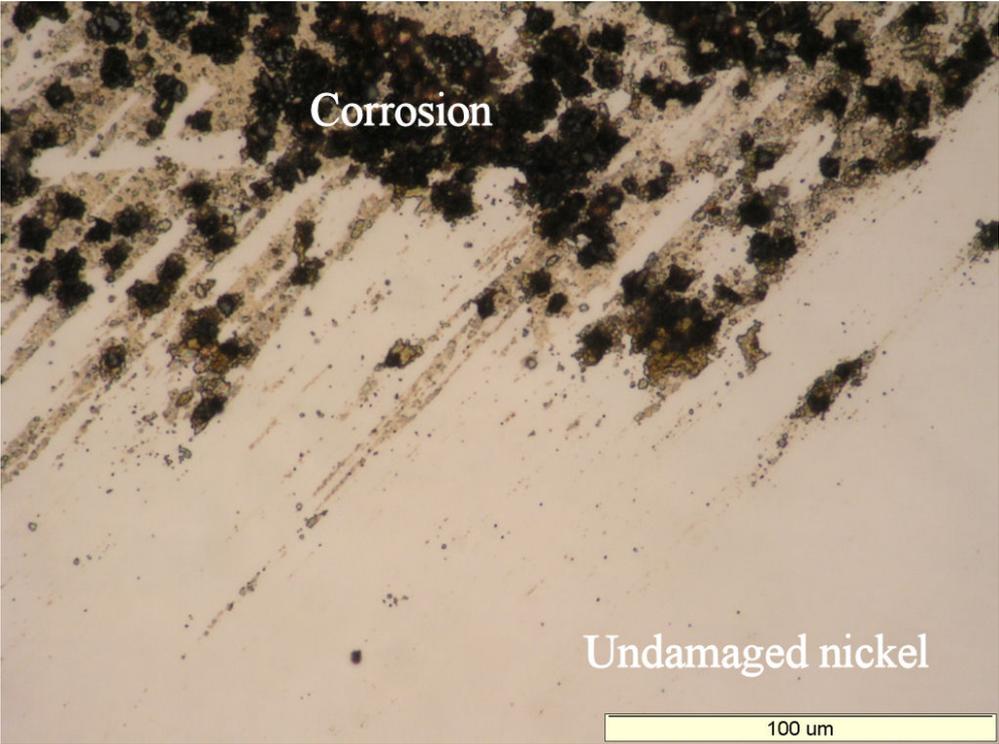
#### Area 1:

The nickel coating is corroded on surfaces close to the plexi-glass top of the block. The corrosion is accelerated around the areas where the copper was first exposed. Therefore, on these surfaces the nickel plating is completely removed, while on less-exposed surfaces the nickel plating is undamaged. Deposits on the nickel and copper surfaces are also visible. Deposits were also observed on undamaged nickel surfaces in the chamber of the block.

Corrosion can be avoided by the use of a low-conducting, anti-corrosion liquid (which, in principle, is also distilled or deionized water). It is recommended to exchange the liquid with a fresh one after a period of time to remove the possibly dissolved ions from the closed water-cooling system. The introduction of additional metals into the system (silver, etc.) or the use of ionic algacides (copper sulfate, etc.) even in minor concentrations can trigger the corrosion processes. Avoid the use of acidic substances, especially when using copper metal.
