EKWB Test Report:

Test of effects of different cooling liquids and additives
on EK nickel plated blocks

Ljubljana, June 1st 2011

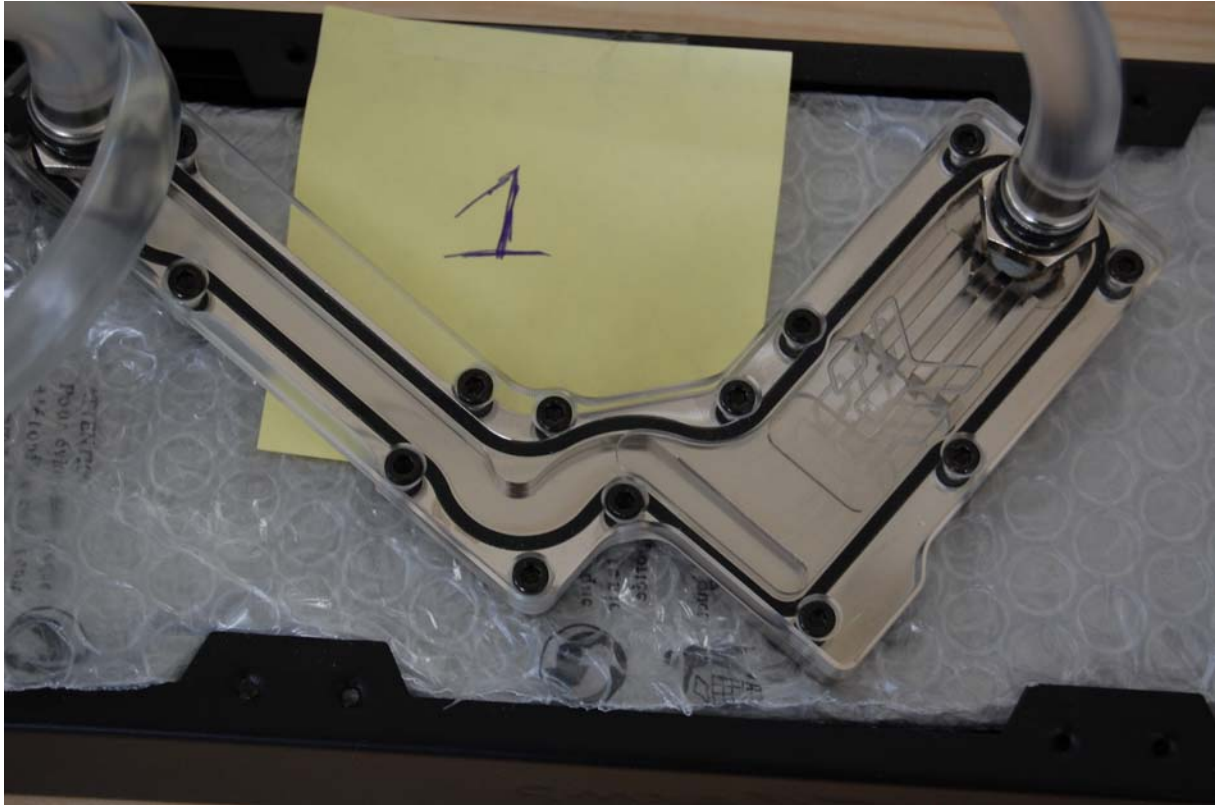
Block #1:

Unflushed radiator + distilled water

Observations: no change on nickel plating

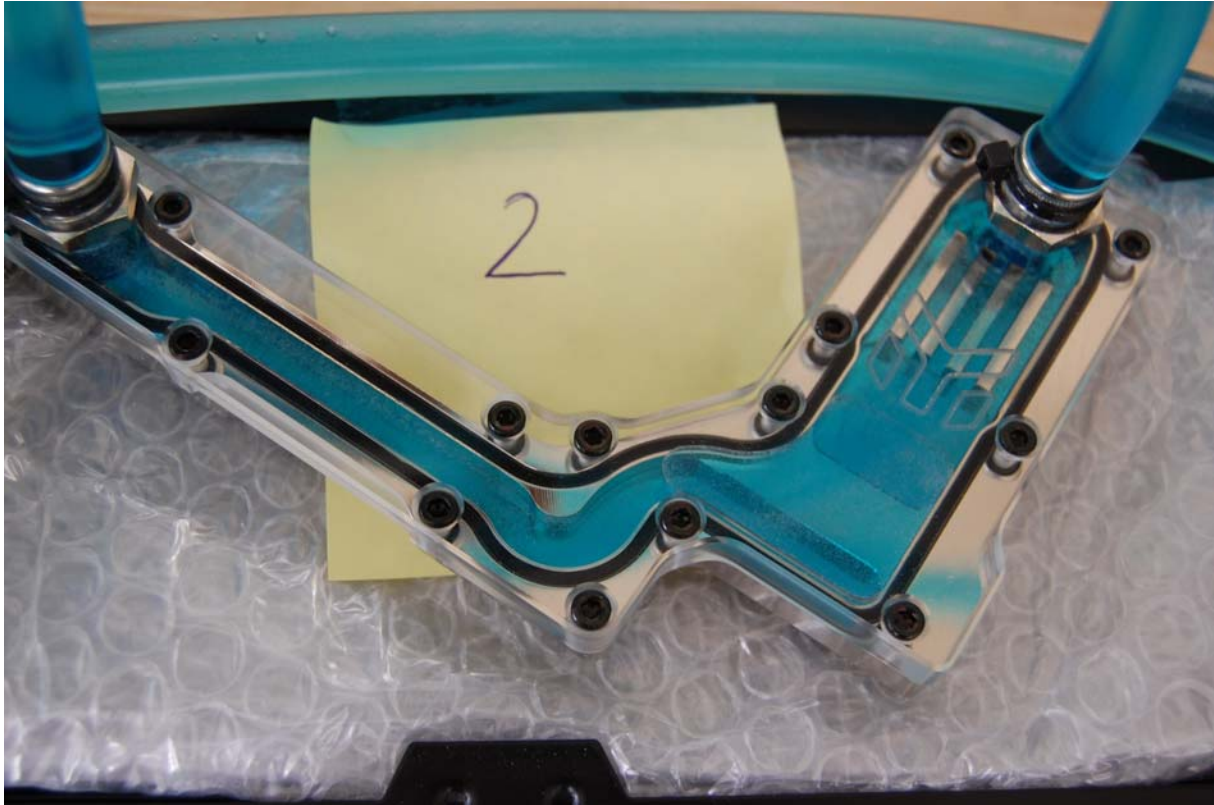
Block #2:

Unflushed radiator + Ekoolant (dye & anti-corrosion fluid) / 1:9 mixed with distilled water

Observations: no change on nickel plating.

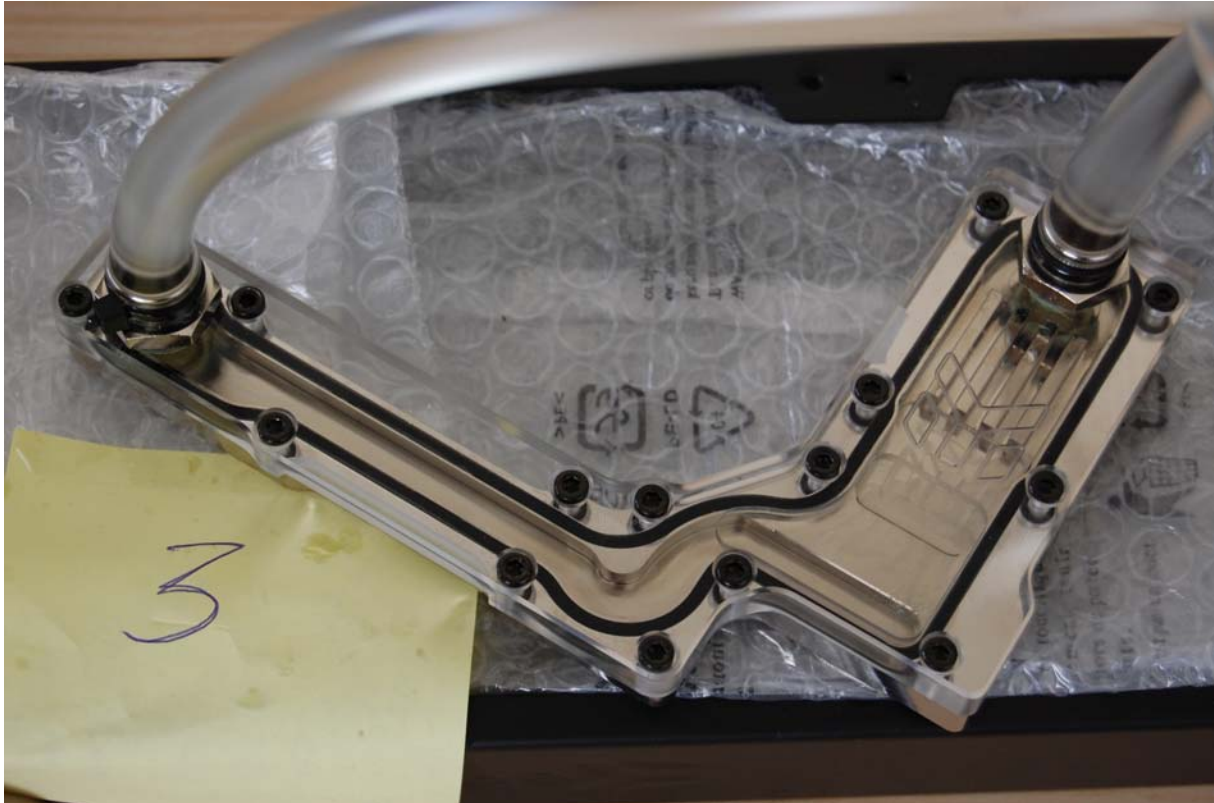
Block #3:

Unflushed radiator + Thermochill EC6 (100%)

Observations: no change on nickel plating

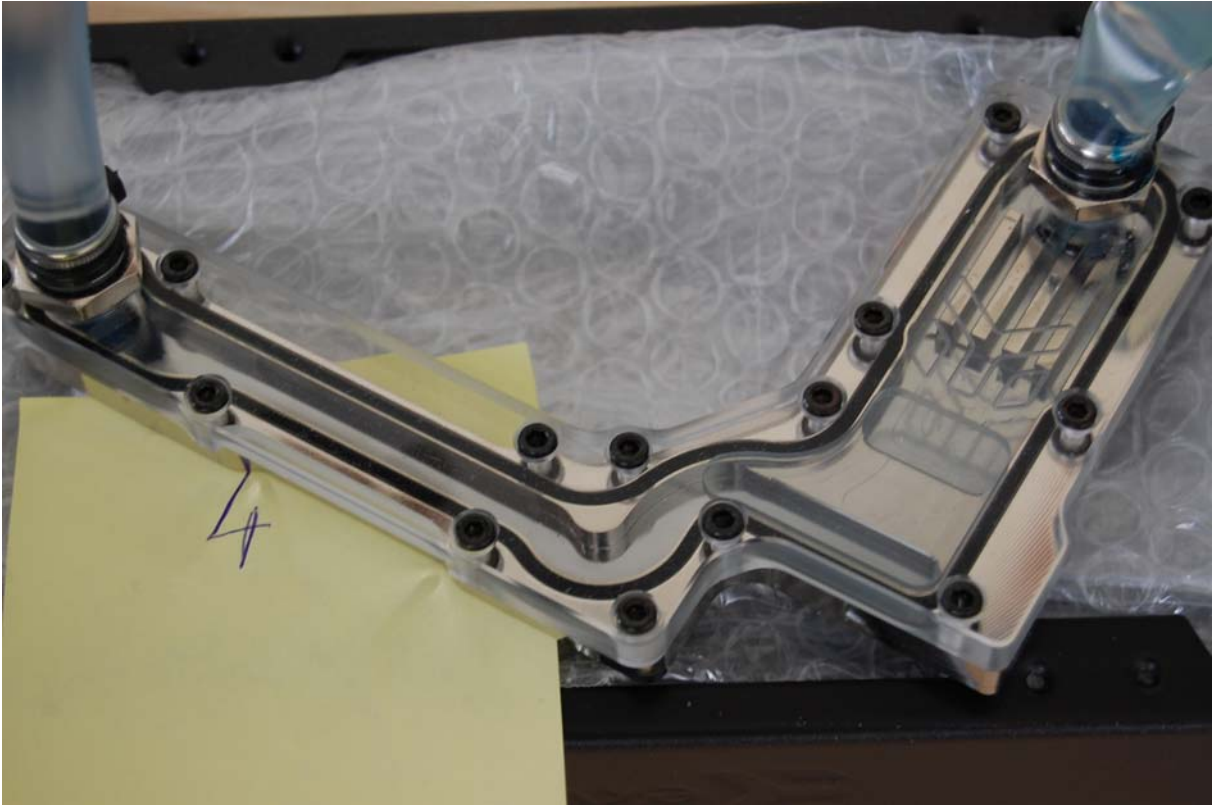
Block #4:

Unflushed radiator + AT Protect UV Blue (100%)

Observations: no change on nickel plating

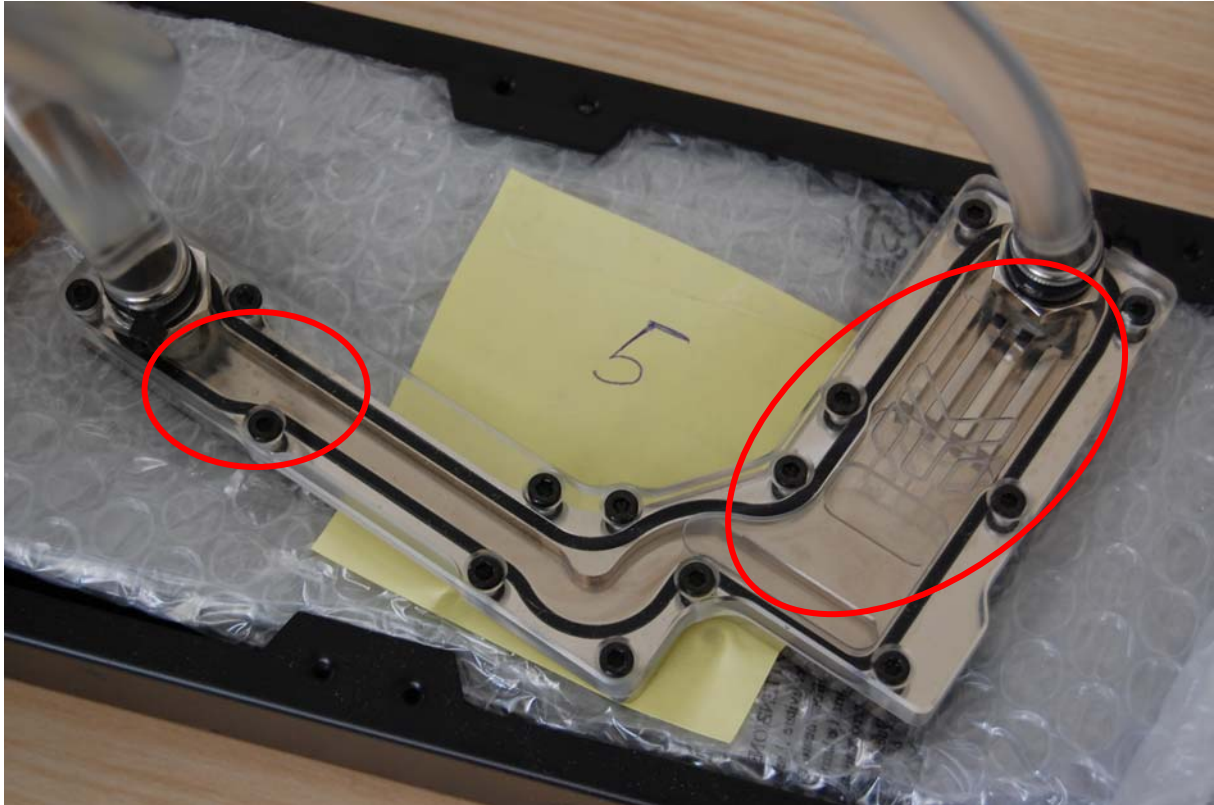
Block #5:

Unflushed radiator + Copper(II) sulfate pentahydrate 4.1% (2 drops) + distilled water

Observations: discoloration, visible staining in marked areas

Up to this date only blocks exposed to copper sulphate, which primary function is algae inhibition, show wear and damage to nickel plating. Based on these tests and considering all blocks are from same batch, we can conclude that this liquid is only culprit so far.

So until further notice we recommend customers with not just EK nickel plated products to use coolant with anticorrosion additive, and do not mix different additives together due to unknown incompatibilities and possible damages not only to nickel plated blocks but to whole watercooling system.

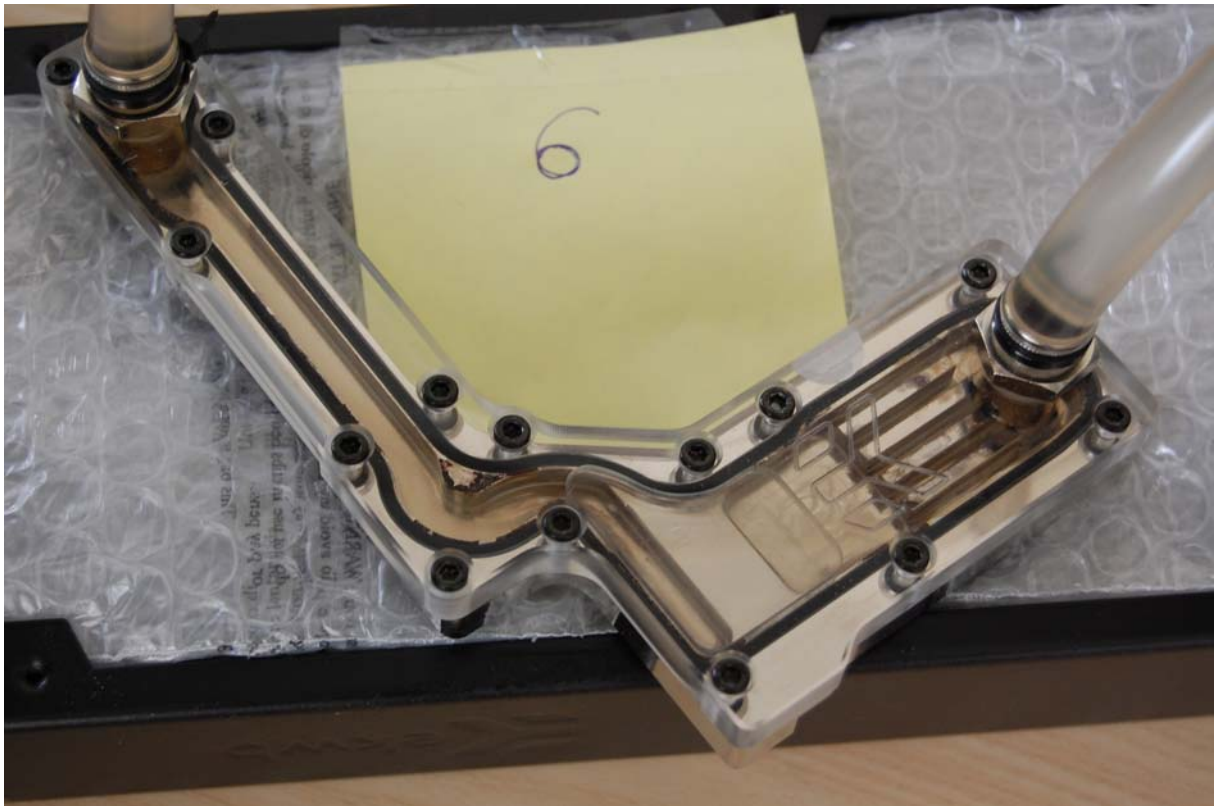
Block #6:

Unflushed radiator + copper sulfat 4,1 % (5 mL) + distilled water

Observations: corrosion of nickel plating (also pictures taken with microscope at the report of the institute)

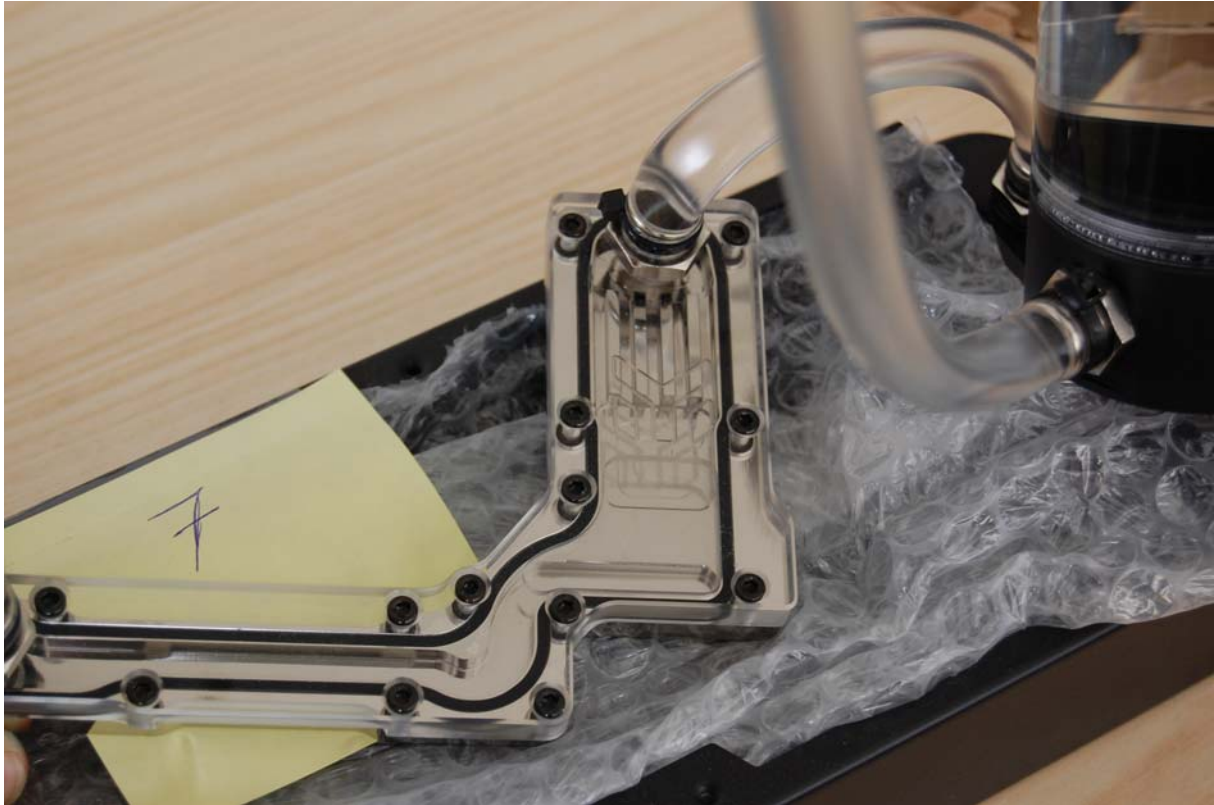
Block #7:

Flushed radiator + distilled water

Observations: no change on nickel plating

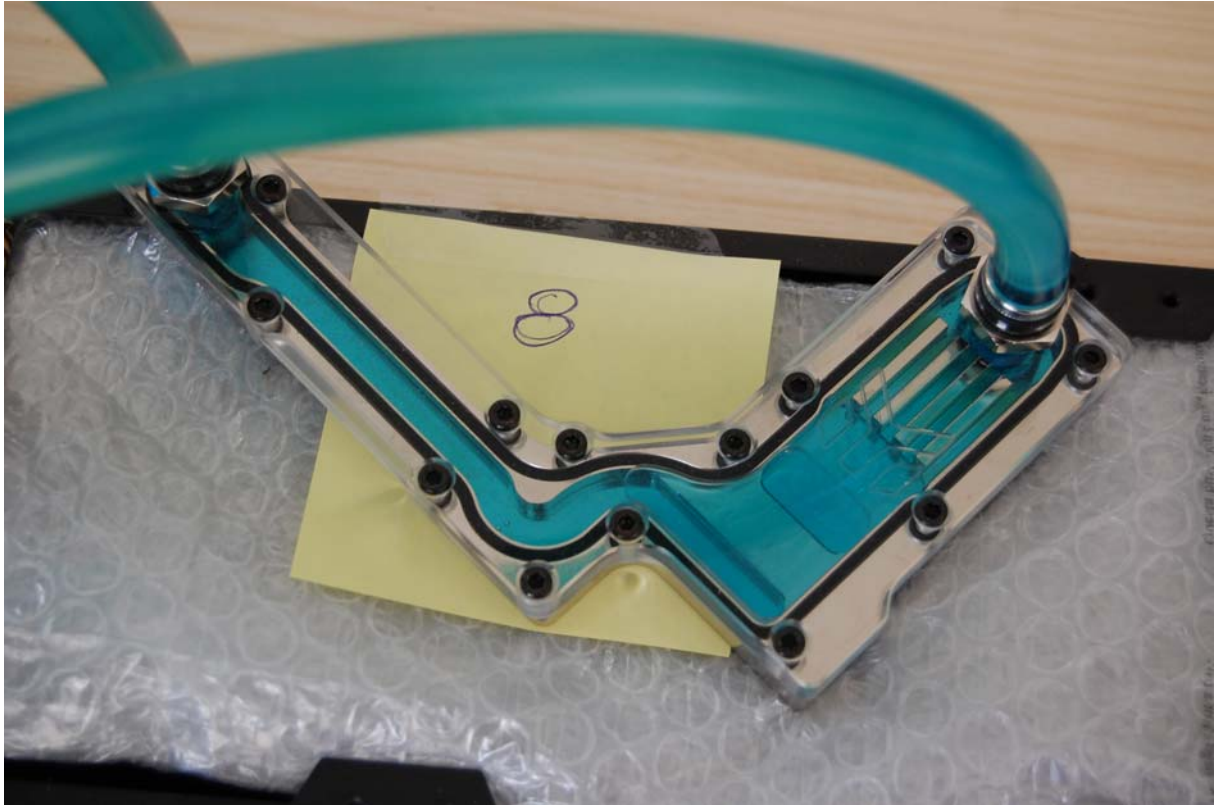
Block #8:

Flushed radiator + Ekoolant (dye & anti-corrosion fluid) / 1:9 mixed with distilled water

Observations: no change on nickel plating

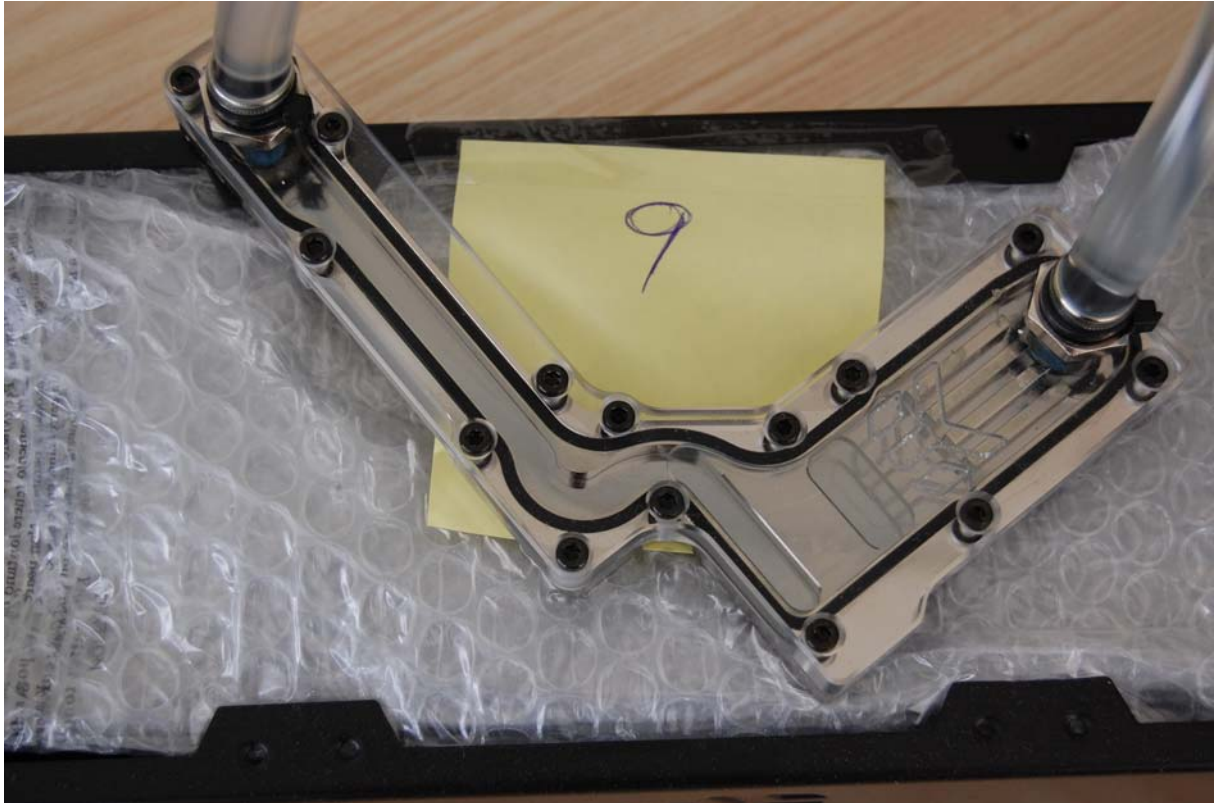
Block #9:

Flushed radiator + AT Protect UV Blue (100%)

Observations: no change on nickel plating

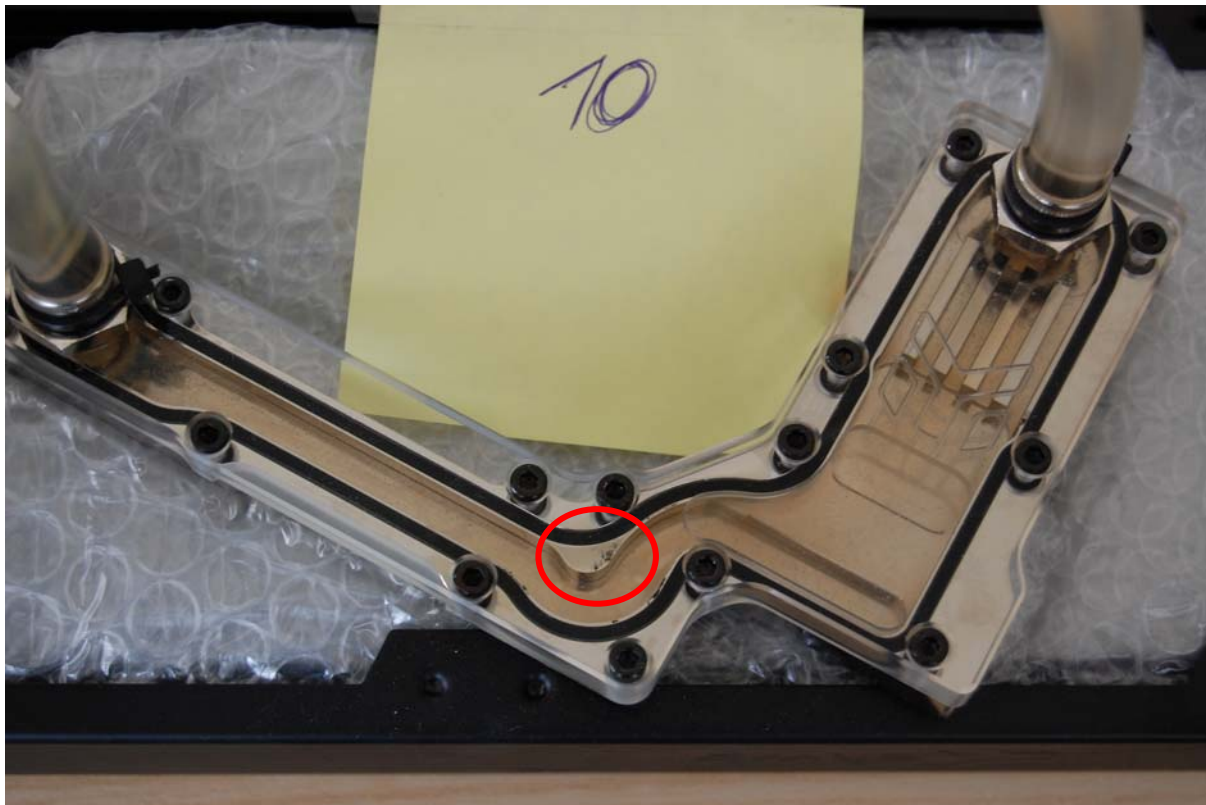
Block #10:

Flushed radiator + copper sulphate 4,1 % (2 drops) + distilled water

Observations: strong staining all over flow path on nickel plating, also start of corrosion in marked area
