TEST: POSSIBLE STAINING ON NICKEL PLATED SURFACES

EKWB Internal Report

1.Reason and testing methods

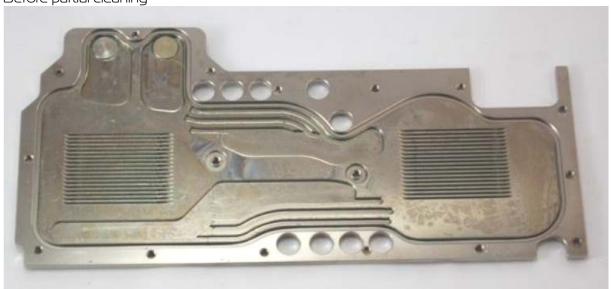
Before partial cleaning

3.4.1. Electroless nickel plating (EN)

The area where we used Ekoolant was easily cleaned by wiping with a paper towel. Discoloration was minimal and is likely to have been caused by glycol.
