*Irregularities on the surface of water-cooling blocks*

*To find reason(s) for the damage to a water-cooling block using the appropriate methods*

# Analysis of the irregularities on the surface of water cooling blocks

EKWB d.o.o., Pot za Brdom 100, SI-1000 Ljubljana

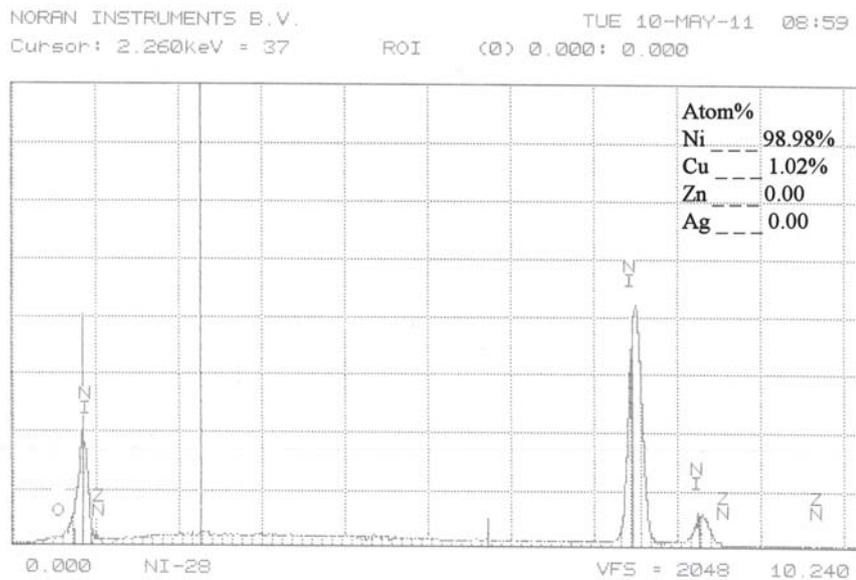
The EDS analysis revealed the approximate chemical composition of the analyzed surfaces. The nickel coating consists of pure nickel (Ni) metal (Fig. 18). No oxygen was detected in the coating, while the copper (Cu) signal comes from the underlying base material. Also for the exposed copper the EDS results show pure copper metal (Fig. 19).

Figure 18: Typical EDS spectrum of a nickel metal coating.

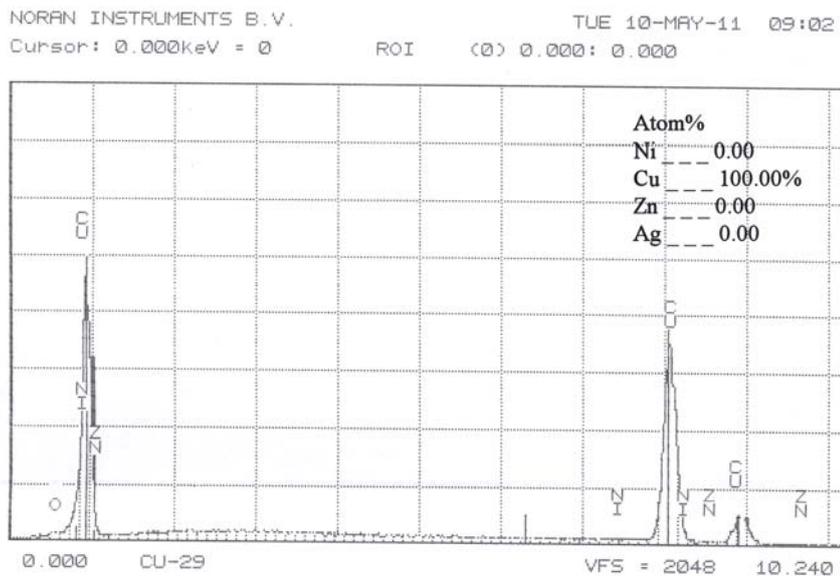
Figure 19: Typical EDS spectrum of a copper metal base.

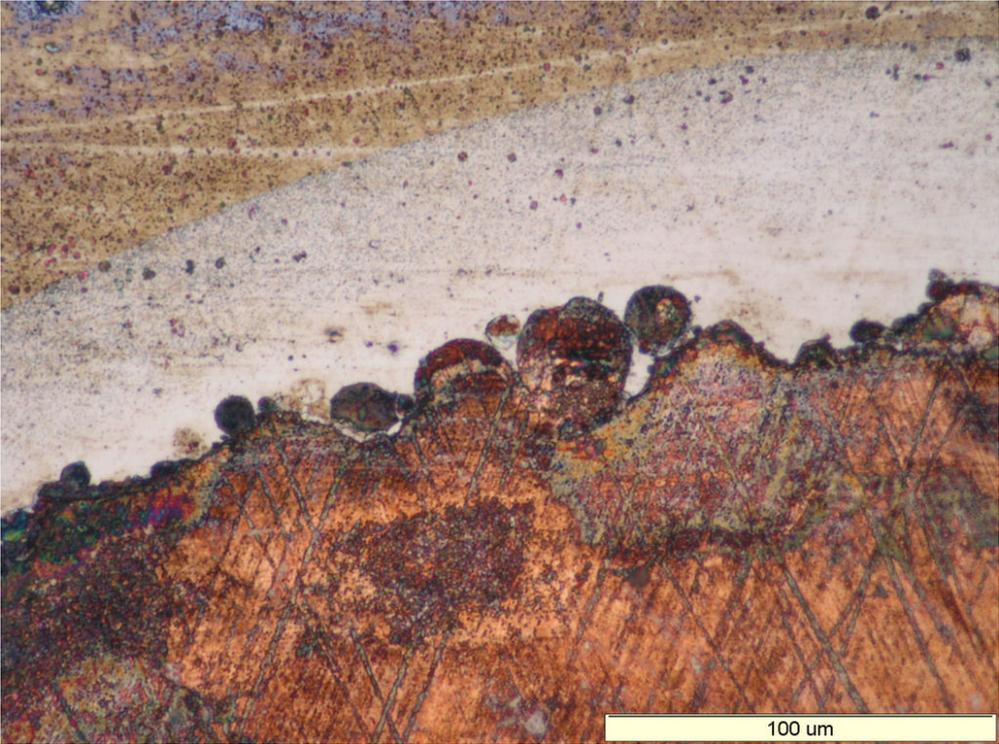
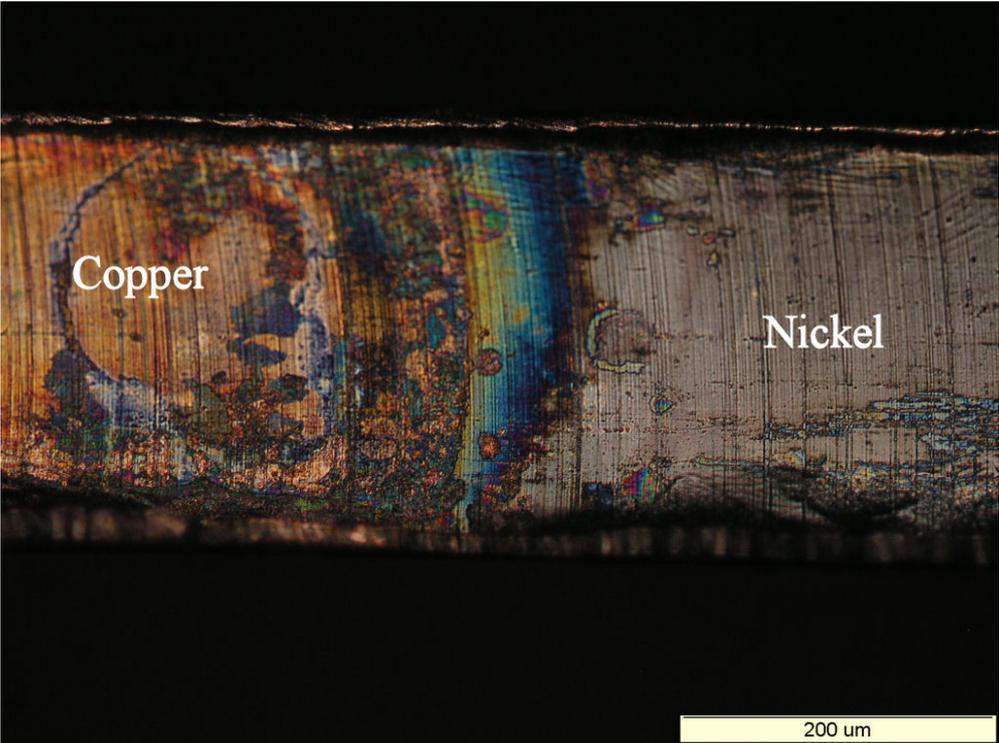
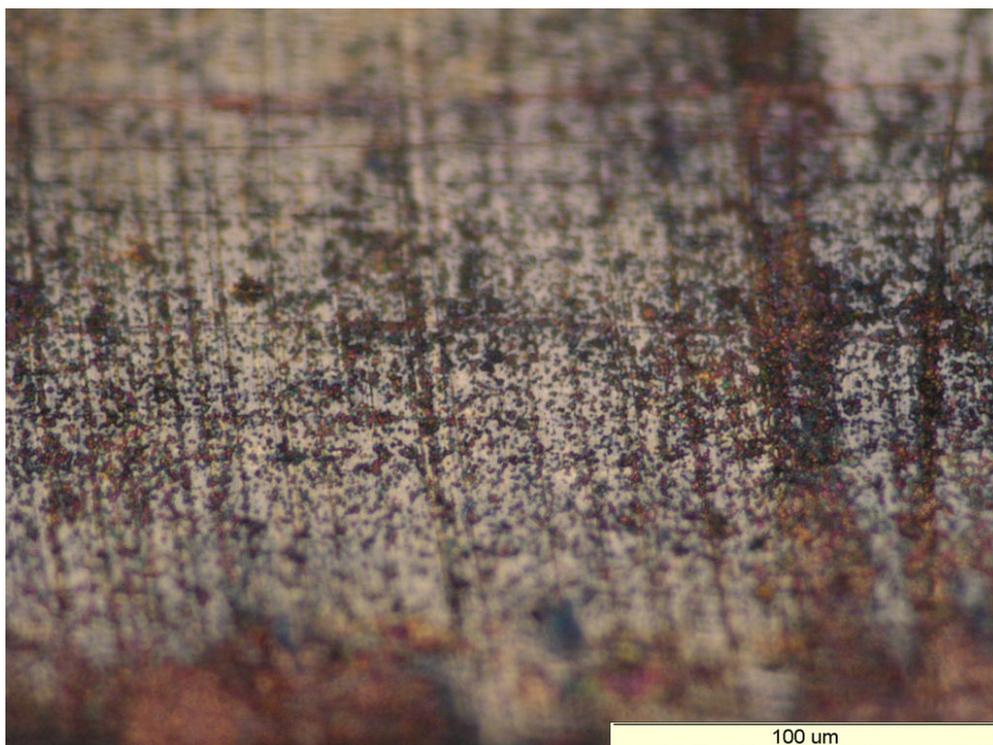
On this nickel-plated, copper, water-cooling block the surface is highly corroded. However, no peeling was detected, indicating good adhesion of the nickel coating. Different ways and progress of the corrosion are visible on different surfaces of the block; preferential corrosion starting at the grain boundaries, and semi-circle corrosion. This is due to different liquid velocities in different parts of the block. Selective corrosion occurred at a place with high a liquid velocity, while a semi-circle was produced by stagnant liquid propagating under the contact of nickel and plexi-glass cover.
